# CITY OF SEATAC CITY HALL

## ASSESSMENT & ANALYSIS FOR THE REDEVELOPMENT OF SEATAC CITY HALL

Prepared in accordance with the  
Agreement for Professional Services between  
City of SeaTac, WA and ARC Architects

March 2021

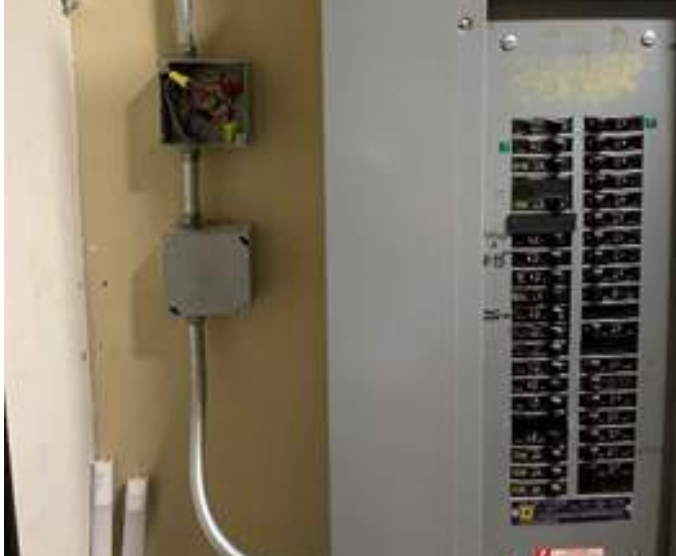
*Top: Building fire alarm control panel located in a corridor near the main lobby.  
Above: Open junction box adjacent to Panel D in first floor central electrical closet should be provided with a cover plate.*

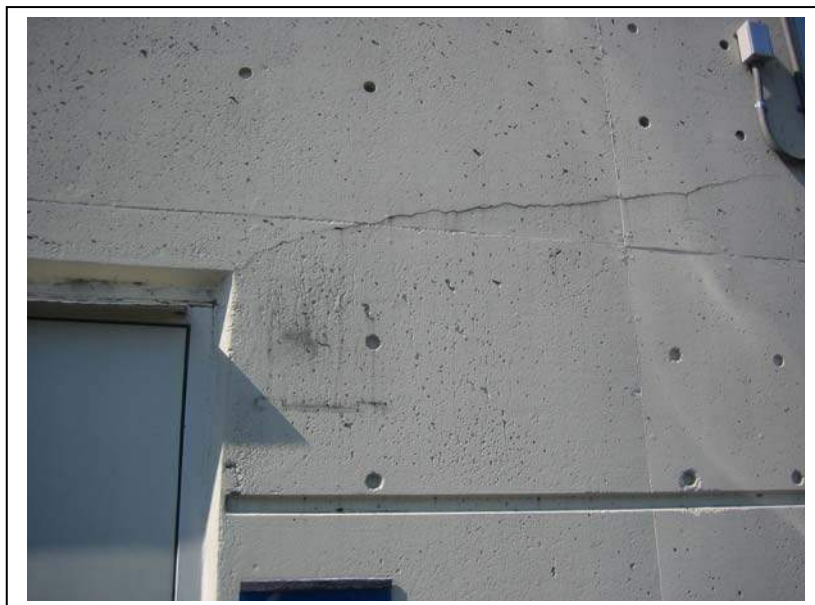
**Photo 8.** Concrete wall crack at Stair B.

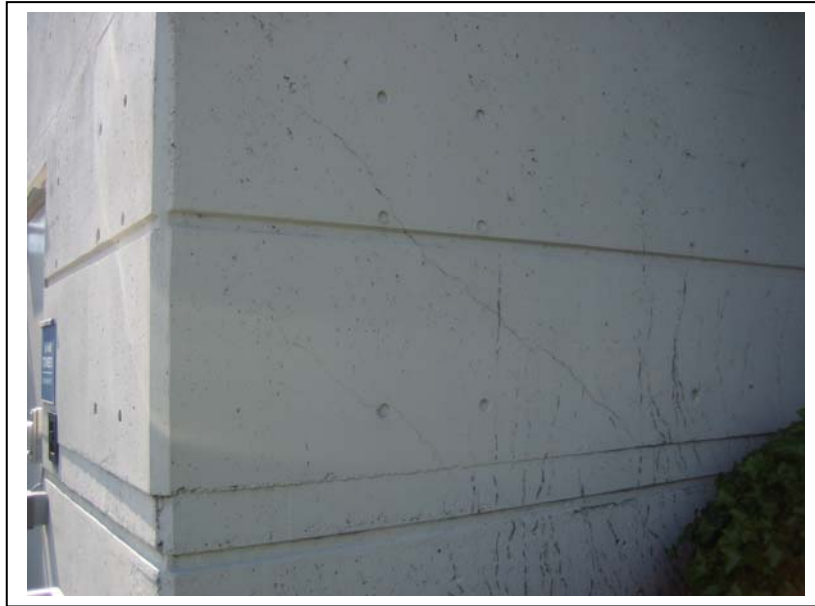
**Photo 9.** Concrete wall crack at Stair B.

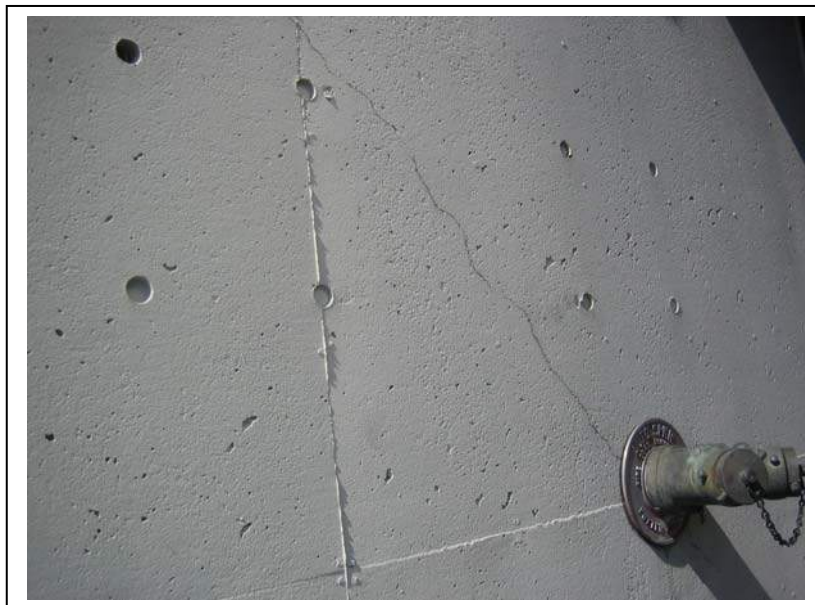
**Photo 10.** Concrete wall crack at Exterior of Elevator.

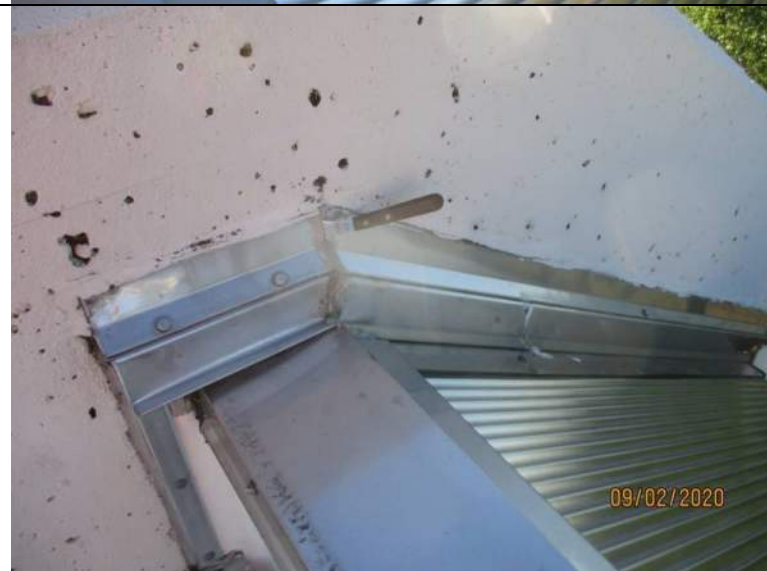
Photograph 6: Similar location as referenced in previous photograph showing a failing sealant joint (sealant knife inserted) where the counterflashing transitions.

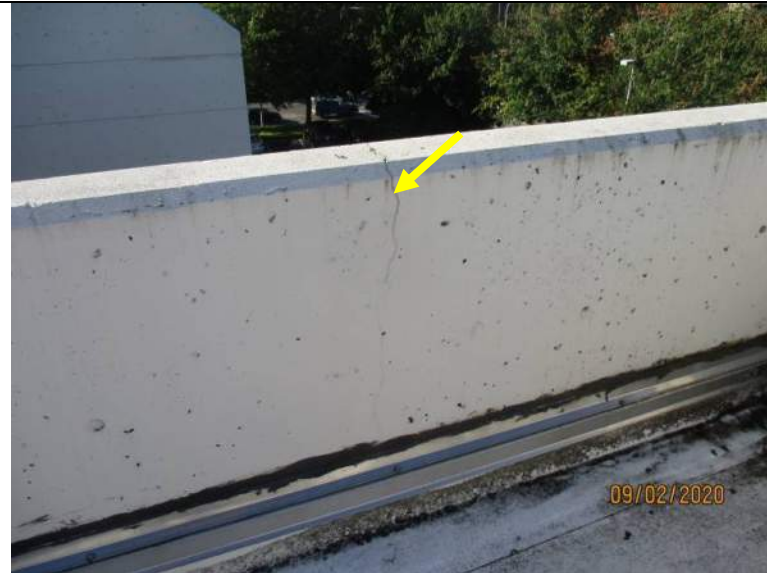
Photograph 7: Cast-in-place wall adjacent skylight over lobby showing counterflashing assembly to shield wall flashing membrane and painted concrete above. Note that top of wall is not capped and crack in concrete (arrow) that can allow water migration behind the roofing.

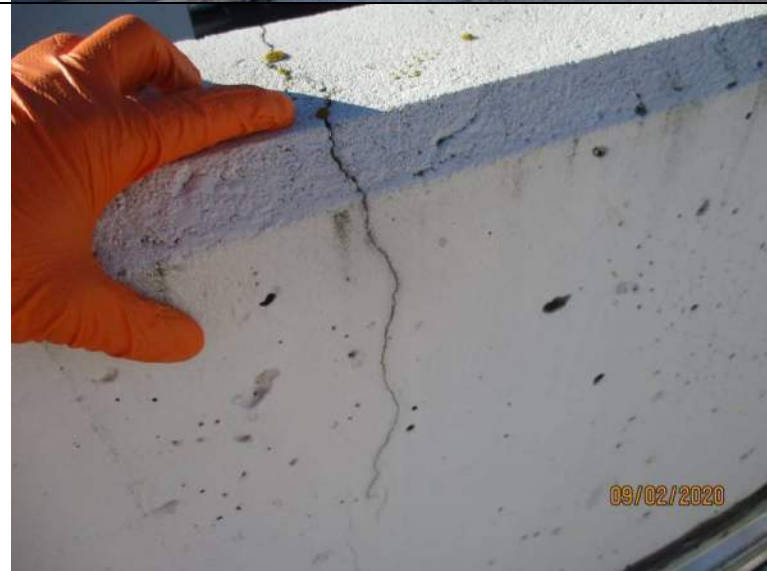
Photograph 8: Close up of previous showing crack in concrete wall.

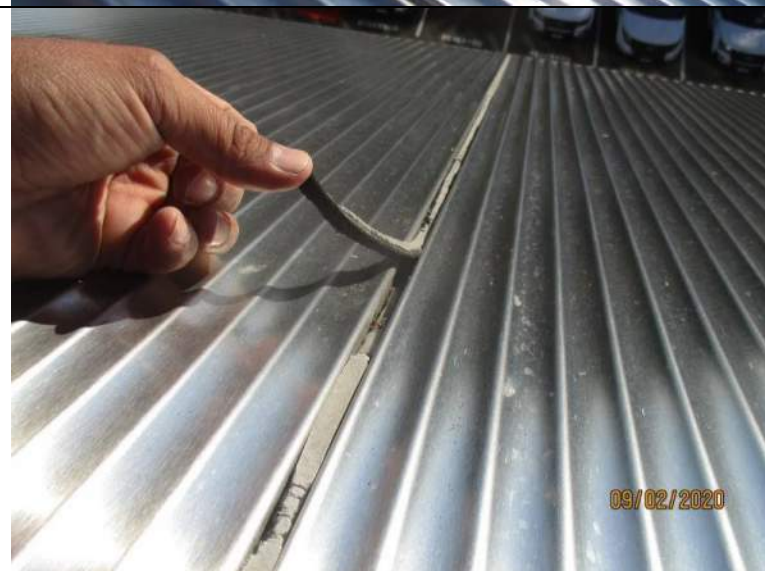
Photograph 12: Deteriorated and loose gasket between stainless steel roof panels.

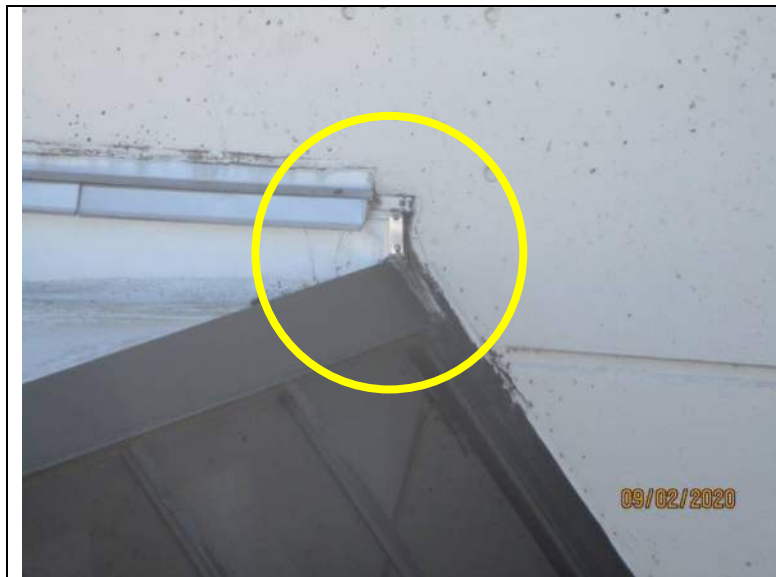
Photograph 13: Exposed termination bar and susceptible counterflashing transition from roof down rake of lobby skylight against concrete wall.

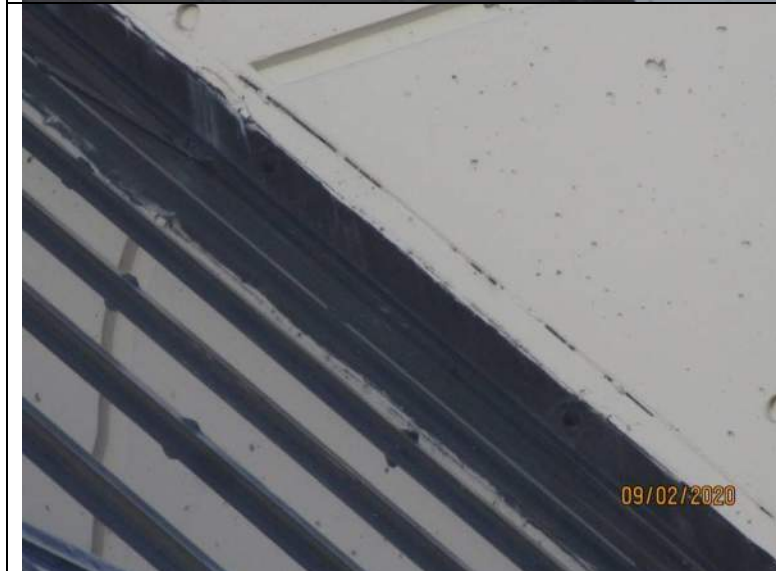
Photograph 14: Lobby skylight rake condition where sealant along inset counterflashing is cohesively failing or discontinuous.

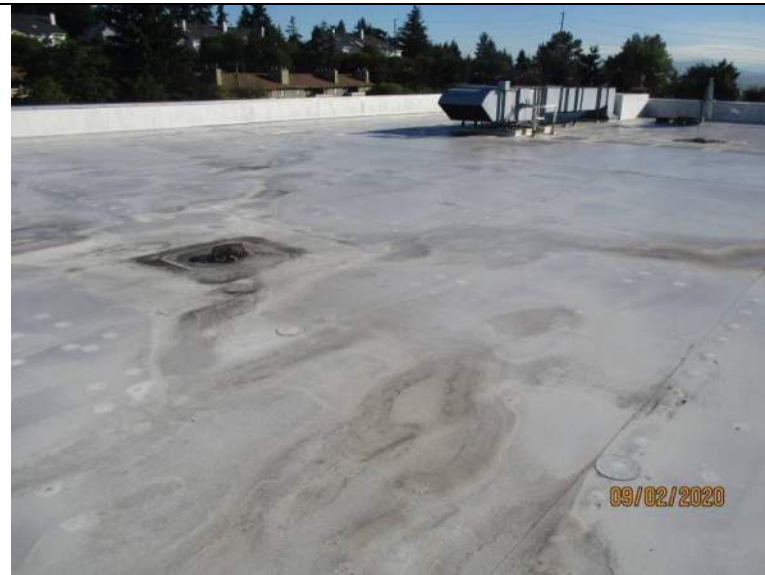
Photograph 22: Staining on roof membrane showing some evidence of standing water adjacent roof drain.

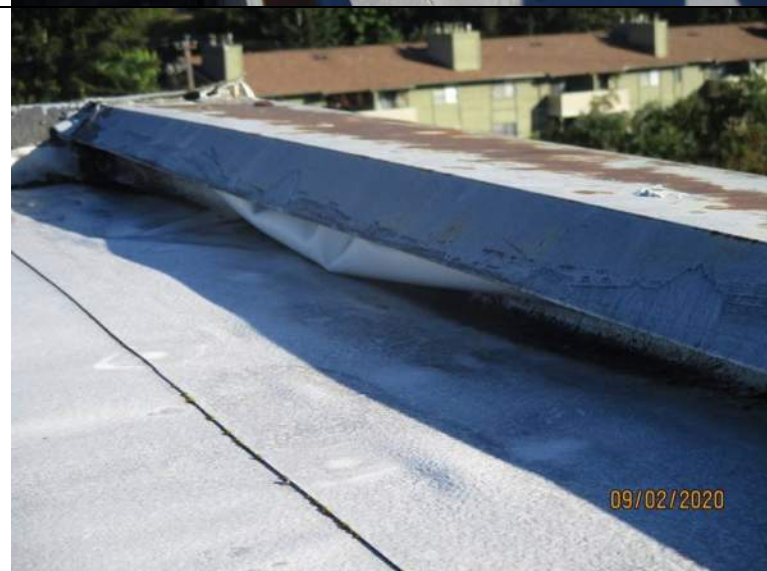
Photograph 30: East perimeter of penthouse roof showing loose and folded down wall flashing membrane.

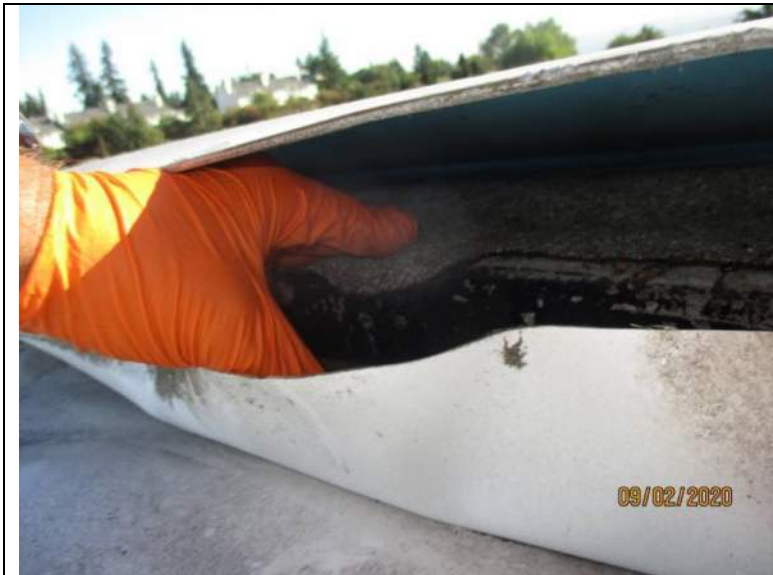
Photograph 31: Same location as previous showing how wall flashing membrane does not wrap the top of the wall. Note existing mineral surfaced membrane under the coping metal.

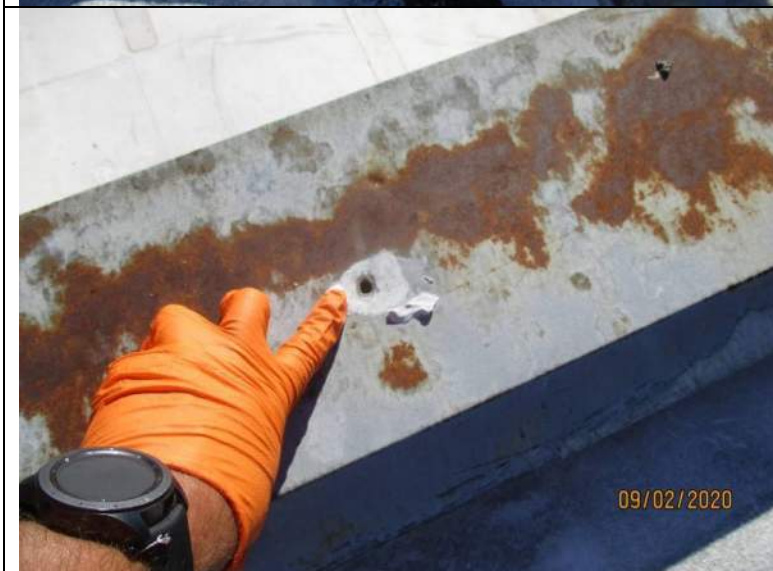
Photograph 33: Poor coping metal condition and hole left from removed fastener.

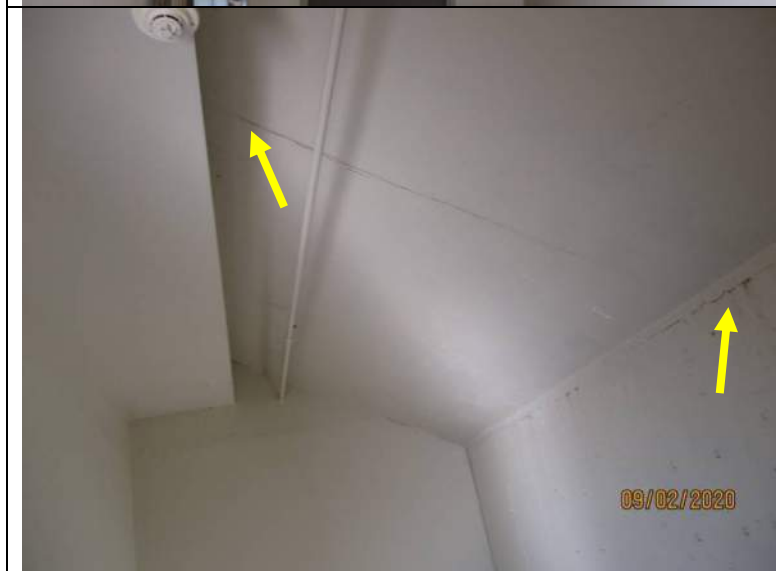
Photograph 39: Penthouse roof, steep slope roof portion. Note streak staining from transition and along cold joint (arrows).

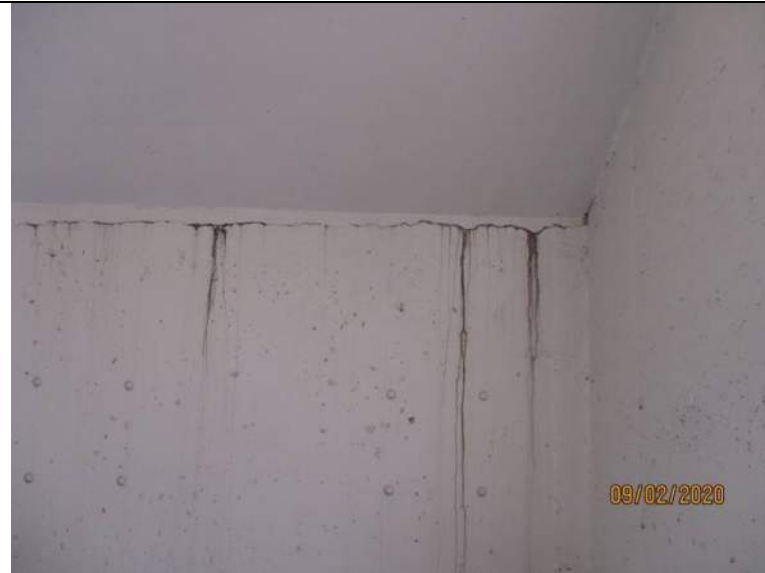
Photograph 40: Streak staining from cold joint between roof slab and wall at north elevation of east staircase penthouse.

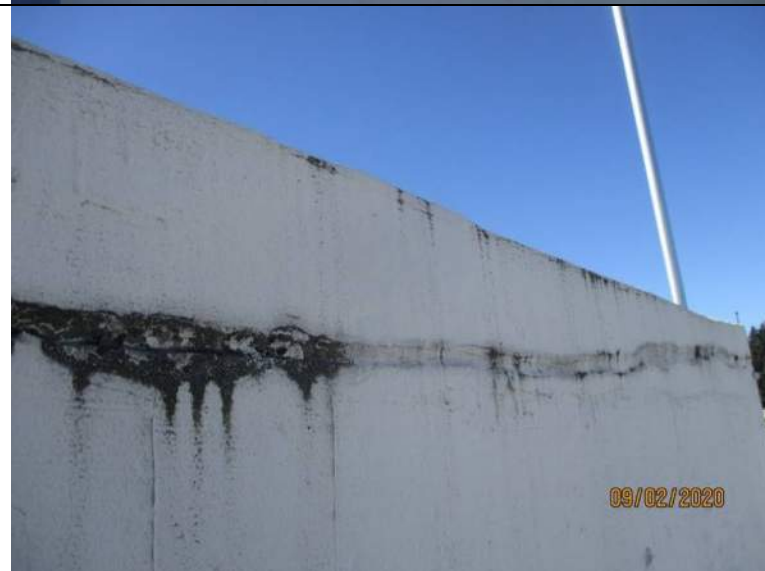
Photograph 42: Adhesively failing sealant at cold joint.

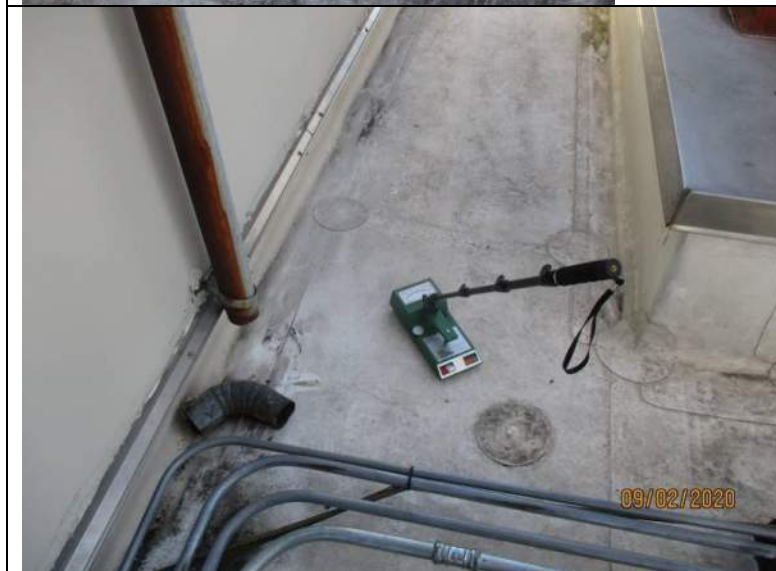
Photograph 48: Tramex RWS moisture meter used to detect an elevated moisture content level on a relative scale next to roof patch/tented membrane.

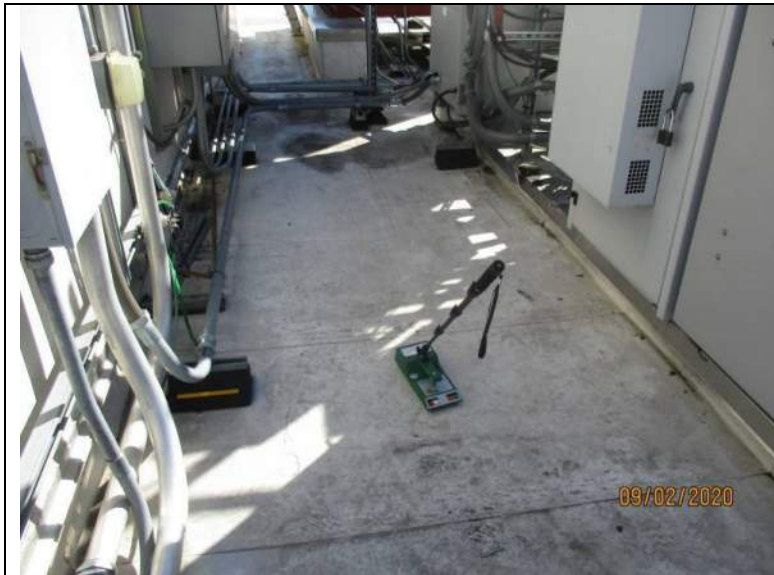
Photograph 49: Tramex RWS moisture meter used to detect an elevated moisture content level on a relative scale next to rooftop cell site equipment.

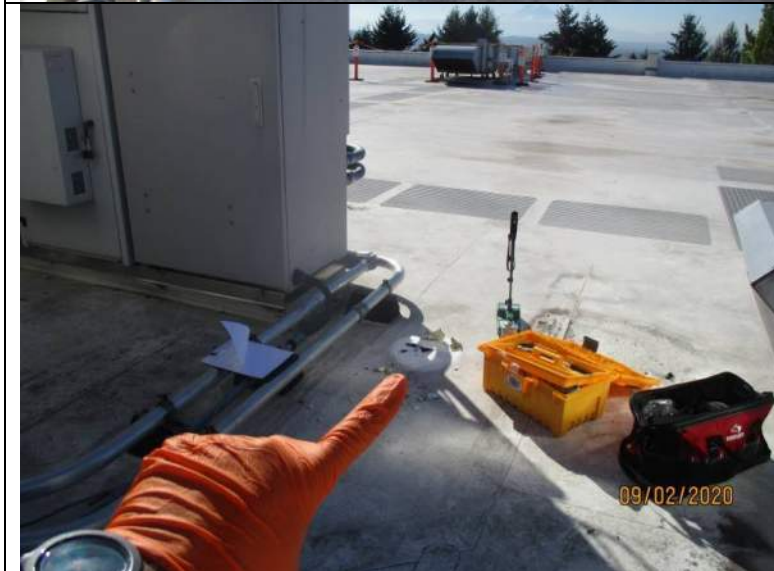
Photograph 50: Location of roof core, just west of the rooftop cell site equipment where elevated moisture readings were also detected.

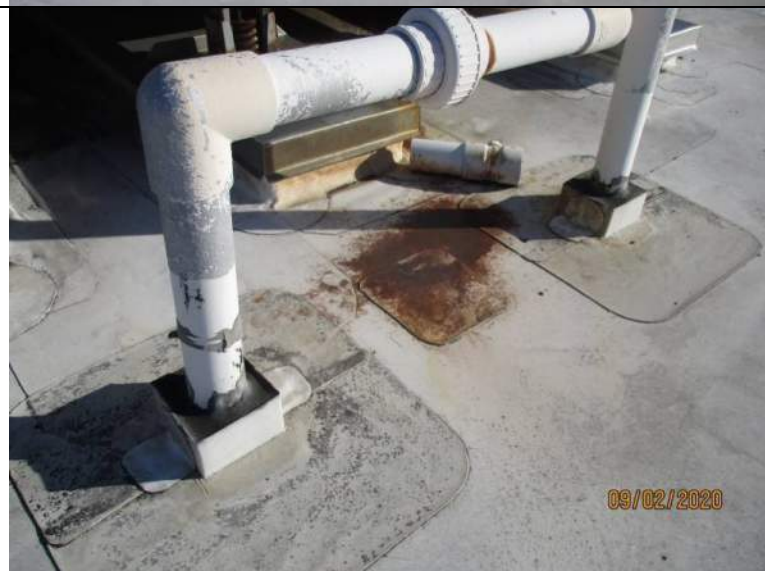
Photograph 58: PVC penetrations flashed with pourable sealant filled clad-metal pockets. Note staining on membrane from apparent leaking at PVC coupler.

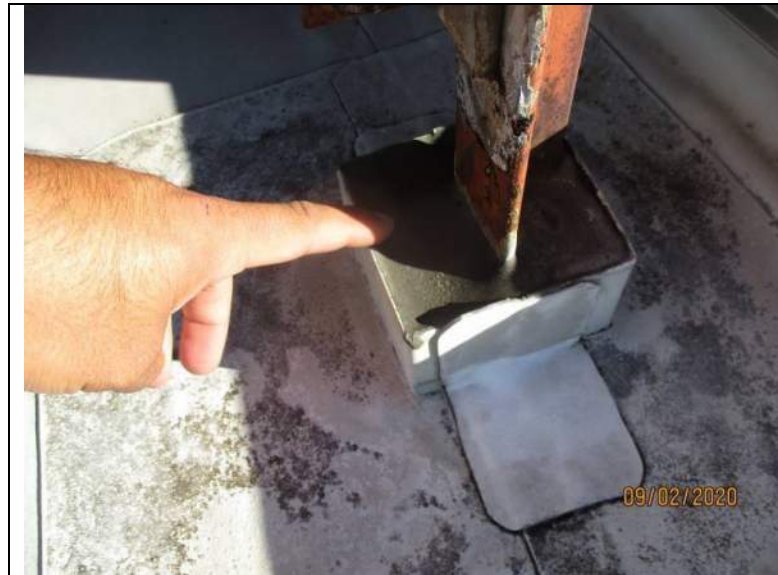
*Photograph 59: Sumped sealant within clad-metal pocket at duct support penetration that will hold water if not filled.*

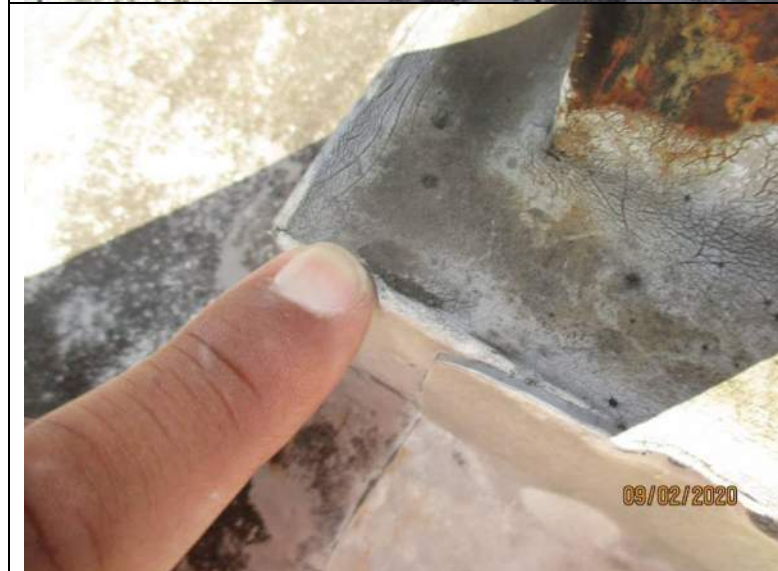
*Photograph 60: Pourable sealant craze cracking and starting to separate at the edges from the clad-metal pocket.*

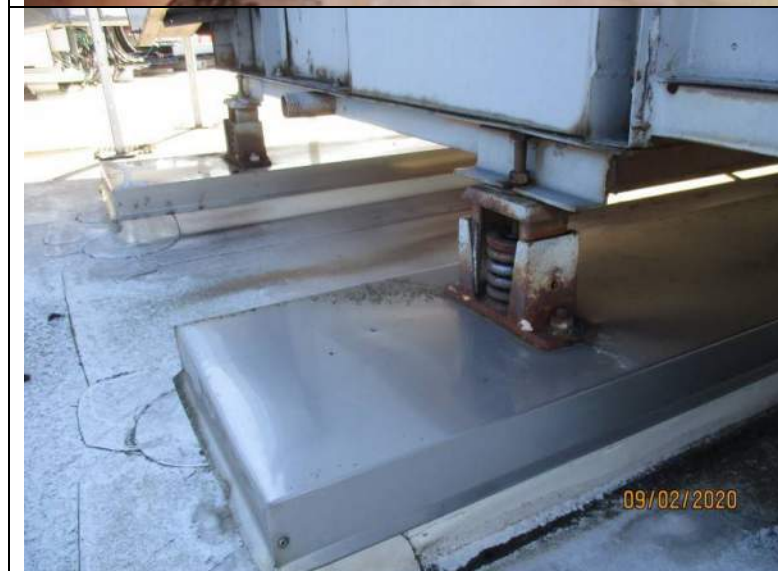
*Photograph 61: Isolator springs anchored through sleeper caps. Penetrations through cap are reliant on regular monitoring and maintenance of sealant to prevent water intrusion.*

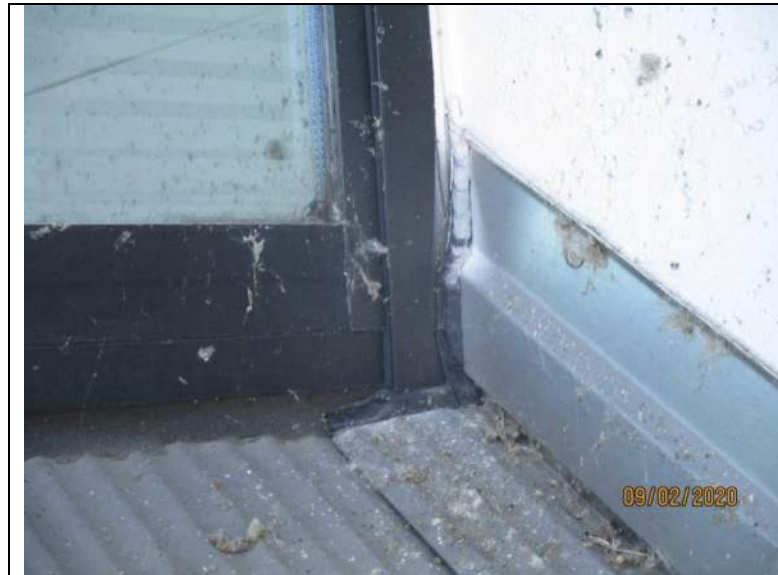
Photograph 70: Same condition as previous photograph showing additional sealant applied likely in response to water intrusion.

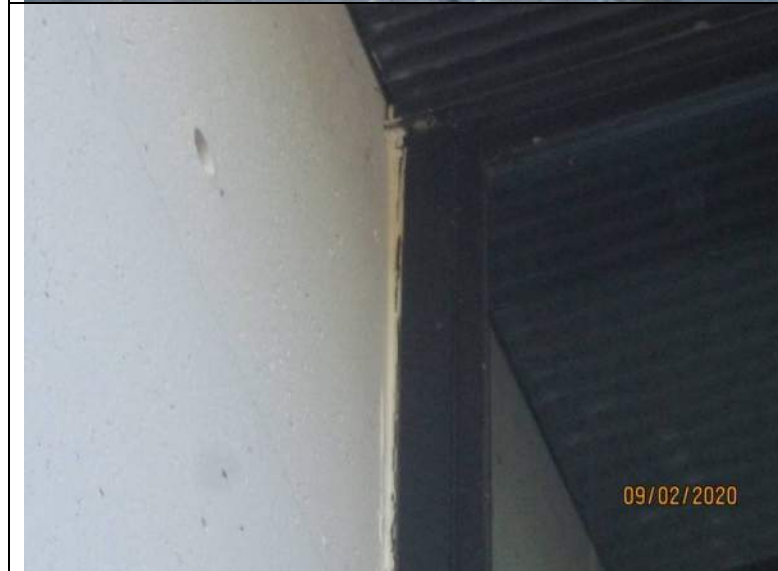
Photograph 71: Failing sealant joint between cast-in-place wall and window frame that needs replacement.

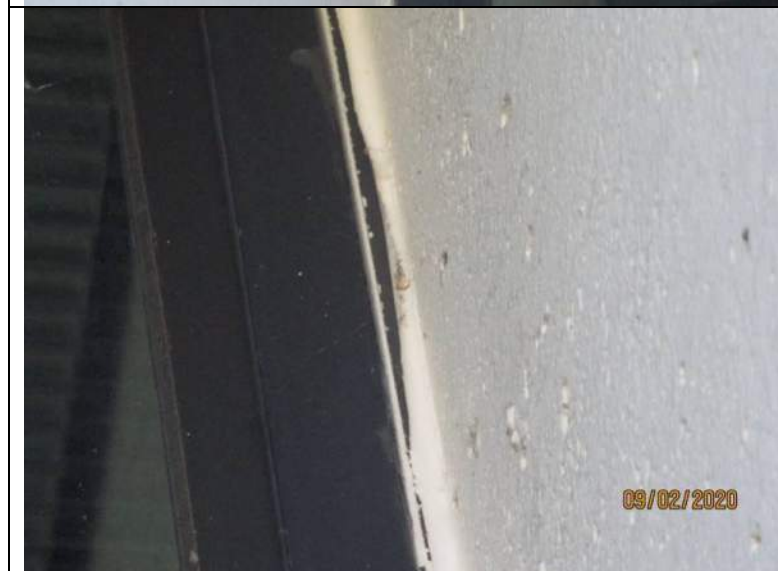
Photograph 72: Failing sealant joint between cast-in-place wall and window frame that needs replacement

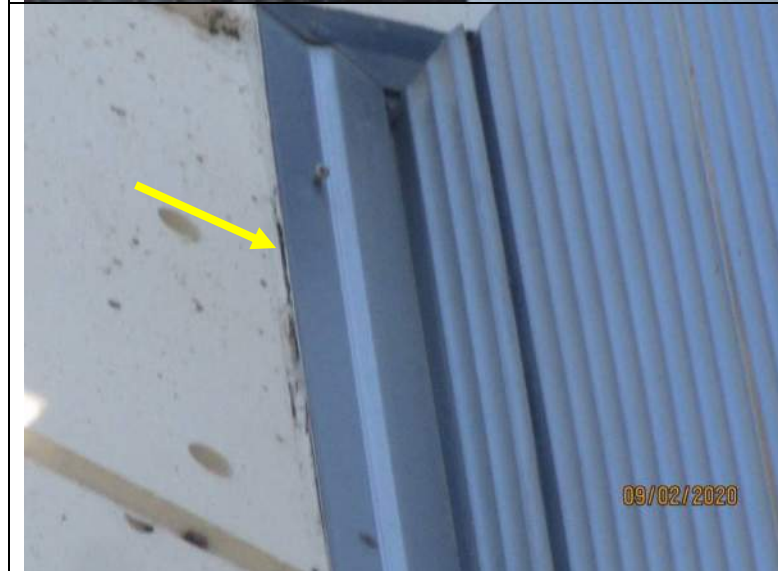
Photograph 74: Failing sealant joint (arrow) and backing out fastener at surface mounted counterflashing that returns down the front of the metal panel structure.

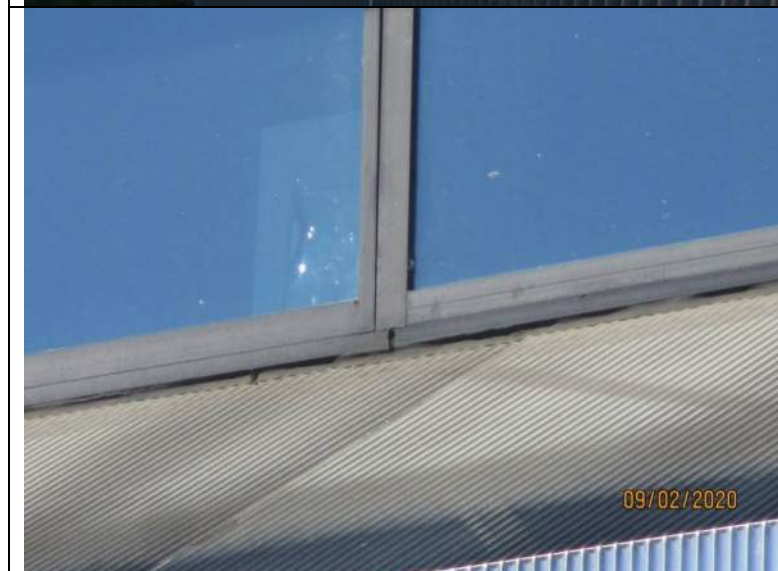
Photograph 78: Recessed or failing sealant along bottom of windows that may require replacement.

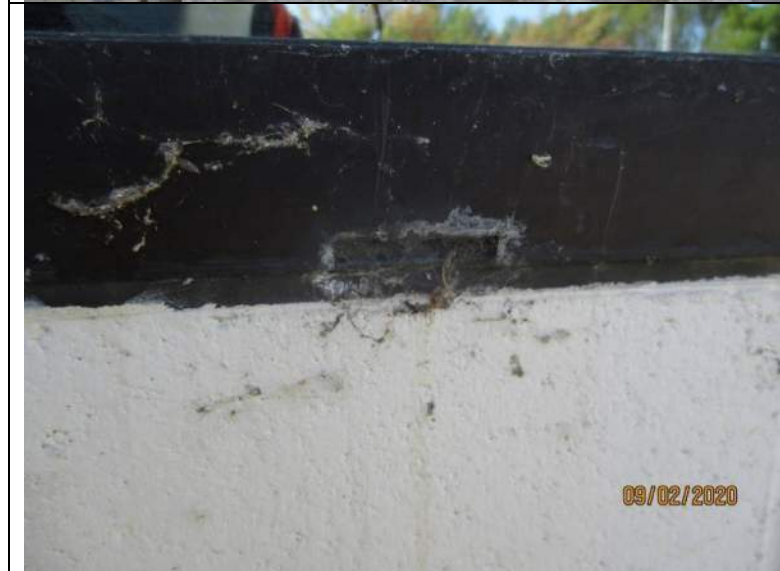
Photograph 80: Weep in window frame at sill blocked with debris. Weep holes should be regularly cleaned out.

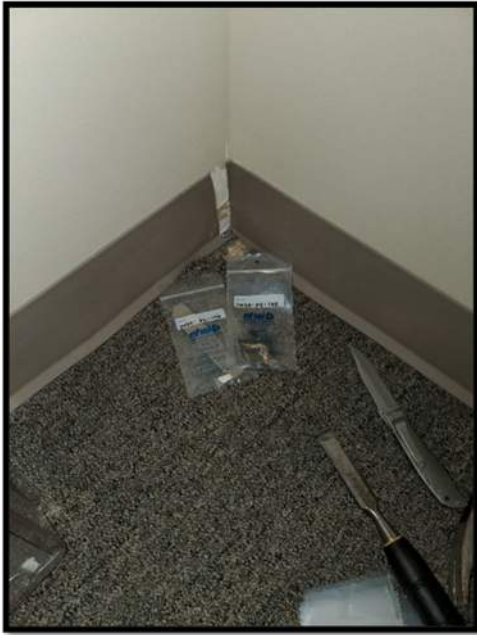
**Photo 5—Sample 11420-F2-145:**  
Non-ACM multi-colored carpet and adhesive over **yellow mastic** on concrete **5% Chrysotile**

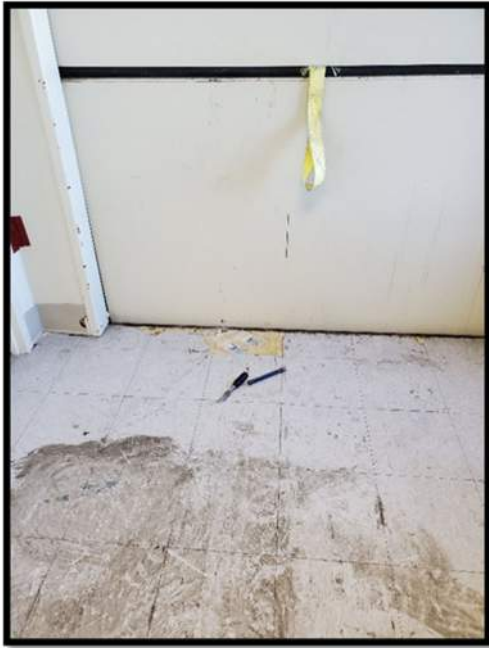
**Photo 9—Sample 11420-F2-174:**  
Non-ACM gray vinyl tile, yellow mastic,  
over white vinyl tile and black mastic 3-  
4% Chrysotile
