TECHNICAL INFORMATION REPORT

NOVEMBER 11, 2021
APCE PROJECT #2021056

PREPARED FOR:
FRONT PORCH HOLDINGS SUBDIVISION
19707 40TH PLACE SOUTH
PARCEL #0240000065
SEATAC, WA 98188

FRONT PORCH HOLDINGS SUBDIVISION TECHNICAL INFORMATION REPORT

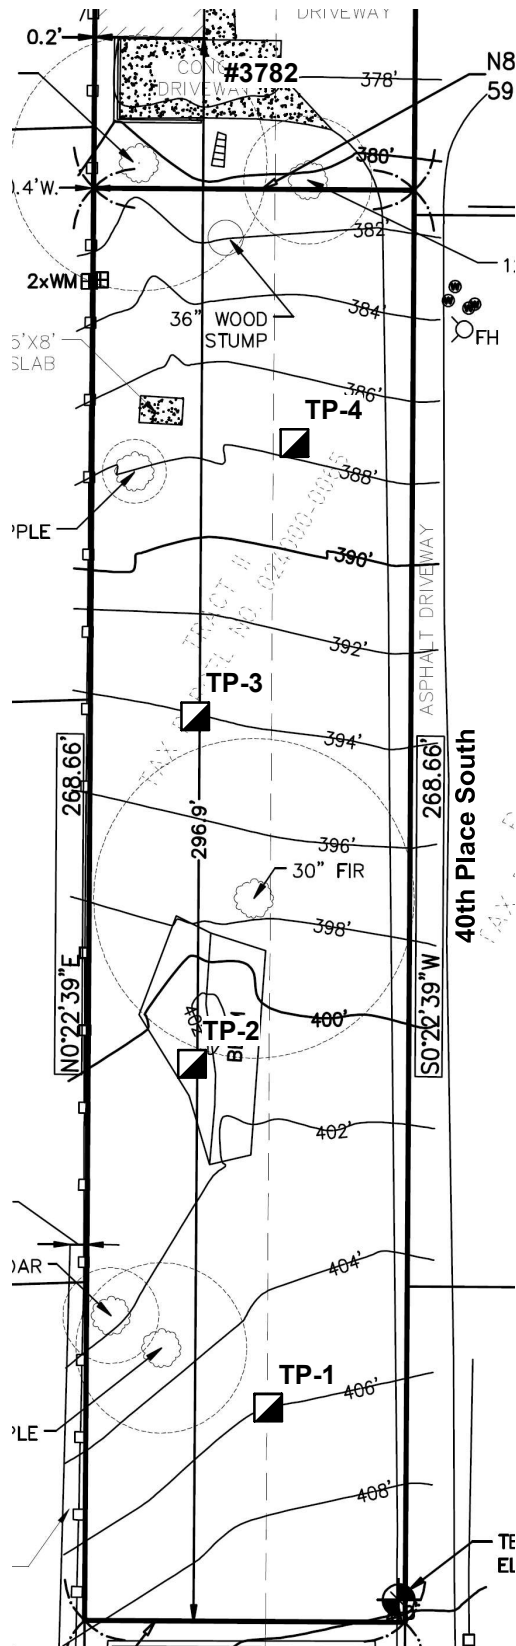
Job No:	Date:	No Scale	Plate:
22009	Jan. 2022	No Scale	2

■ Test Pit Location

Plate 1	Vicinity Map
Plate 2	Site Exploration Plan
Plates 3 - 4	Test Pit Logs
Plate 5	Typical Footing Drain Detail

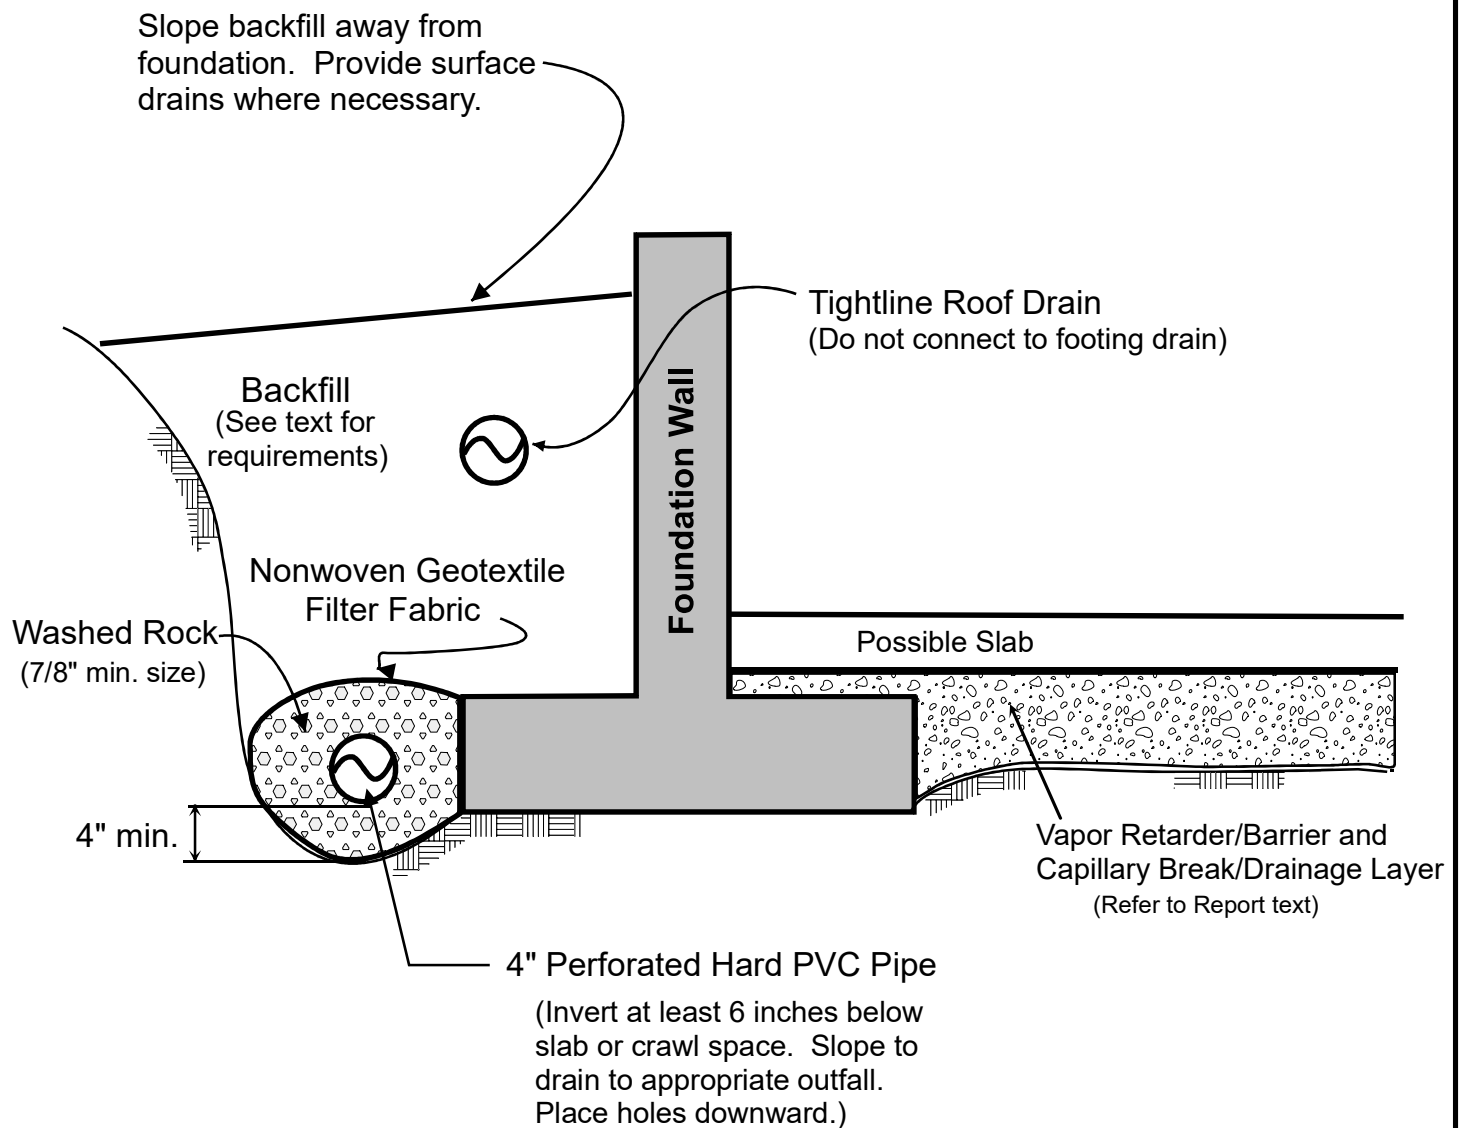
- (1) In crawl spaces, provide an outlet drain to prevent buildup of water that bypasses the perimeter footing drains.
- (2) Refer to report text for additional drainage, waterproofing, and slab considerations.
