# CITY OF SEATAC CITY HALL

## ASSESSMENT & ANALYSIS FOR THE REDEVELOPMENT OF SEATAC CITY HALL

Prepared in accordance with the  
Agreement for Professional Services between  
City of SeaTac, WA and ARC Architects

March 2021

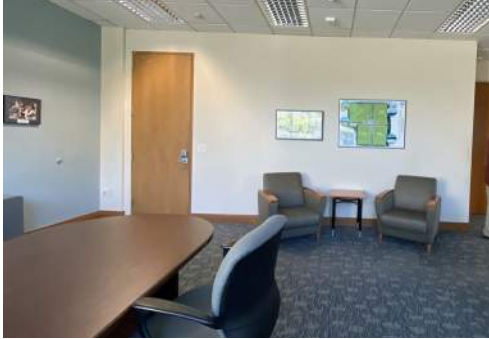
Below: From the Parks Department, the Riverton Room is located on the other side of the door that is shown. By code, egress from a room is not allowed to pass through adjoining or intervening rooms.

Per IBC 1016.2, egress through intervening spaces is not allowed except when such areas are accessory, are not a Group H occupancy, and provide a discernible path of egress travel to an exit. At City Hall, egress from the Parks Department is currently subject to an intervening space, the Riverton Room. This current layout does not comply with the building code and a new design to the layout of the facility must address this deficiency.

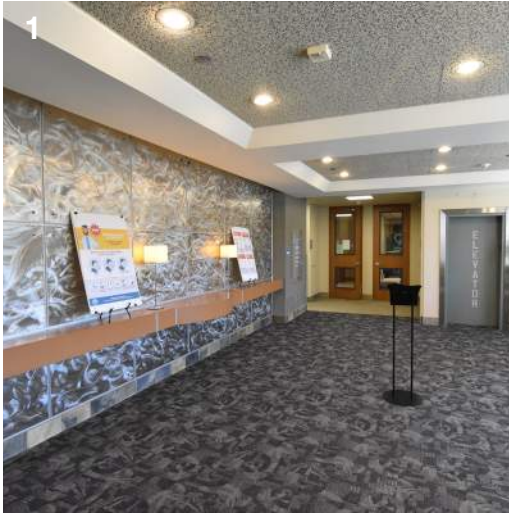
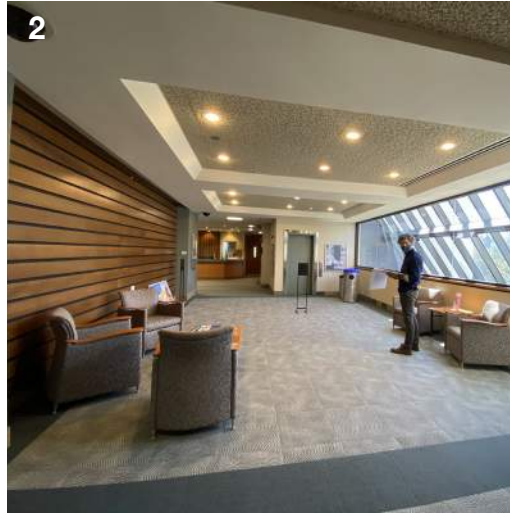
1-2. The second and third floor elevator lobbies function as open waiting areas, but there is a lack of clarity and wayfinding direction for visitors upon arrival. In Image #2, the reception desk is located just beyond the elevator.

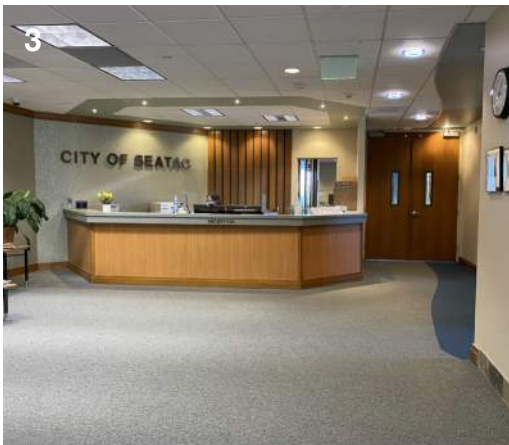
3. City of SeaTac Reception counter. Access to the Permit Center is located off to the left through an unsecured door.

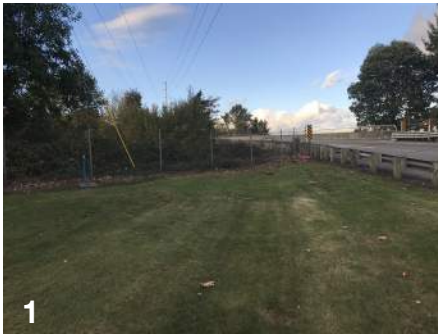
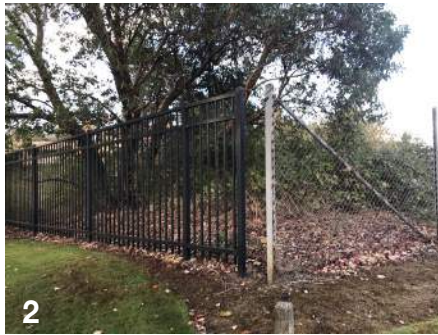
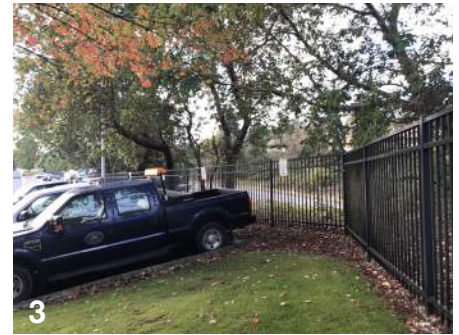
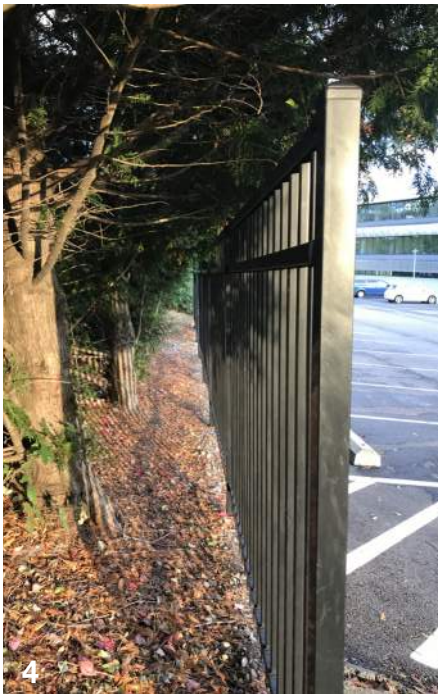
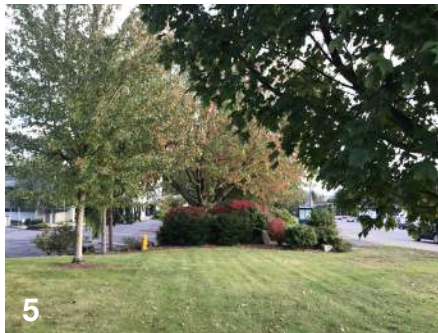
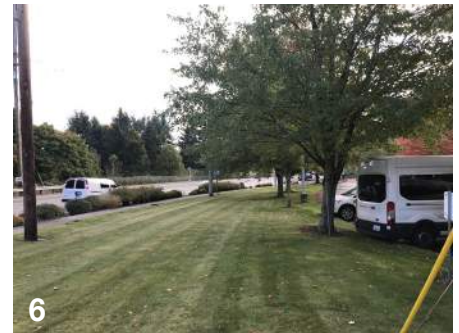
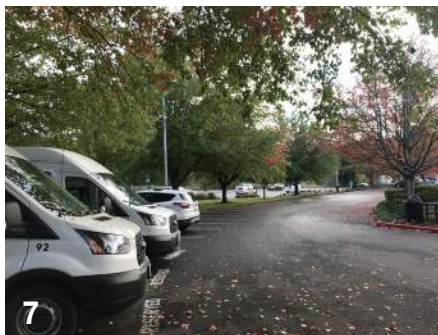
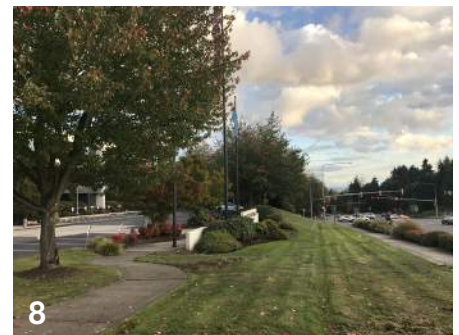
The only existing perimeter fencing is located along the northern edge of the SeaTac City Hall property. The eastern portion of the fence is 7' tall chain link, and meets the 7' tall steel picket fence approximately 60' west of the northeast property corner.

1. Northeast property corner where chain link fence meets guardrail at Military Road. 2. There is an approximately 12" gap where the chain link fences meet the picket fence. 3. Facing west, the picket fence continues along the length of the northern property boundary to the west end of the parking. 4. At the western terminus of the picket fence, facing east, the fence does not tie into other perimeter security and planting outside of the fence intrudes into clear space. 5. Facing SSE between parking lot and Orillia Road, north of vehicle entry, ample landscape buffer exists to install additional perimeter fencing. 6-7. Facing WSW between parking lot and Military Road, north of vehicle entry, ample landscape buffer exists to install additional perimeter fencing. 8. Facing SSE between parking lot and Orillia Road, south of vehicle entry, ample landscape buffer exists to install additional perimeter fencing. Recommend coordinating fencing with the flagpole plaza and sign wall.

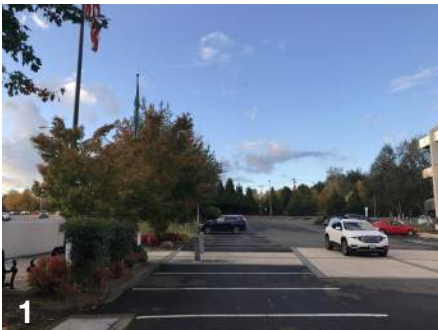
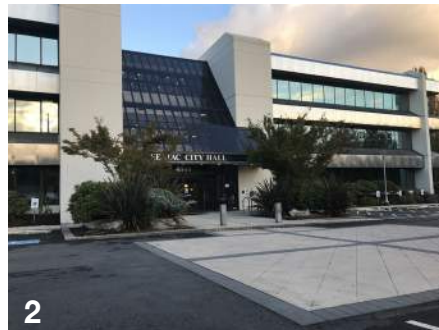
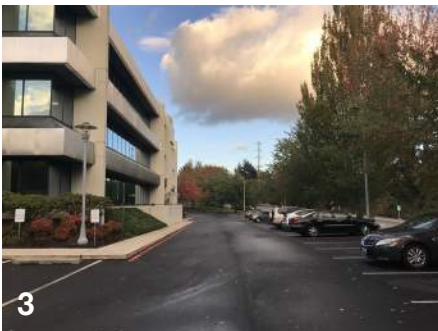
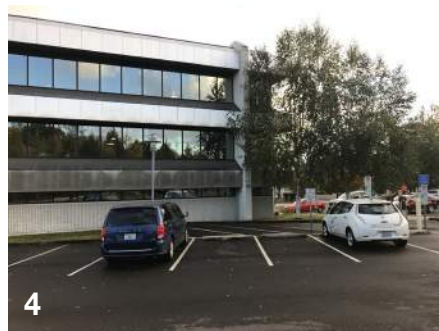
1. Visitor parking west of main building entrance. 2. Accessible parking at main building entrance and bollards at entry plaza. 3. City Council parking south of the main building entrance. 4. Electric vehicle parking at northwest corner of building.

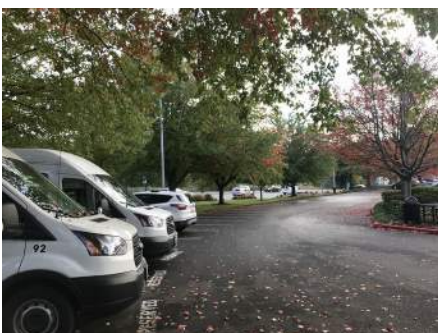
Street and pedestrian scale light occurs throughout the site with inconsistent lighting coverage due to spacing and vegetation. Additional or improved lighting could be installed near vehicle access points and at building ingress/egress locations.

*Example of lighting obscured by vegetation*

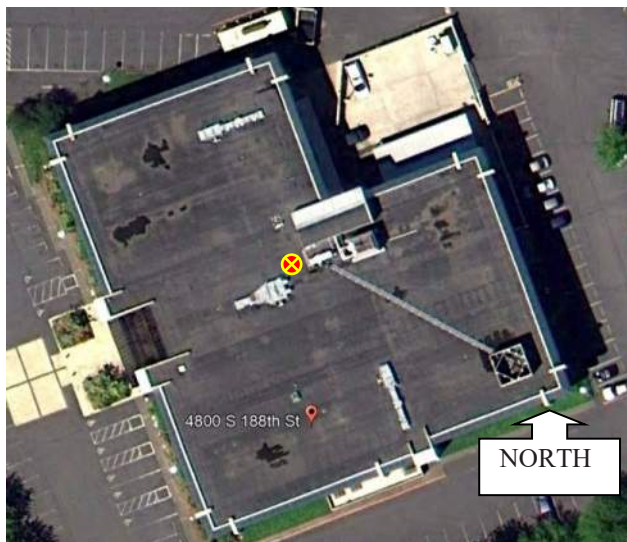
*Figure 1 – Historical aerial image of roof from 6/2010 showing apparent BUR or EPDM assembly. Approximate location of core cut performed is denoted with

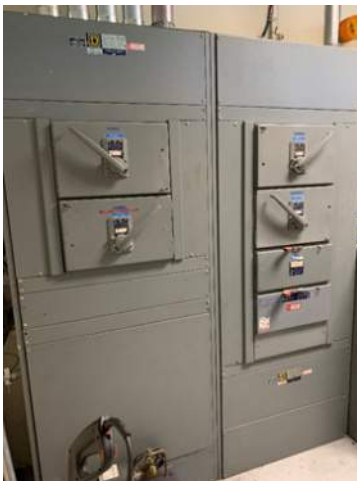
*Building main switchboard located in the main electrical room. The NED required working space in front of the switchboard should be kept clear of foreign objects.*

In many electrical closets throughout the building, including the main electrical room, the central electrical closets on all three floors, and the 3rd floor main telecom room, areas in front of panelboards were observed to be used for miscellaneous storage. The working spaces required by NEC article 110.26 shall be kept clear at all times. It is recommended that all foreign objects in code required work spaces be removed immediately.

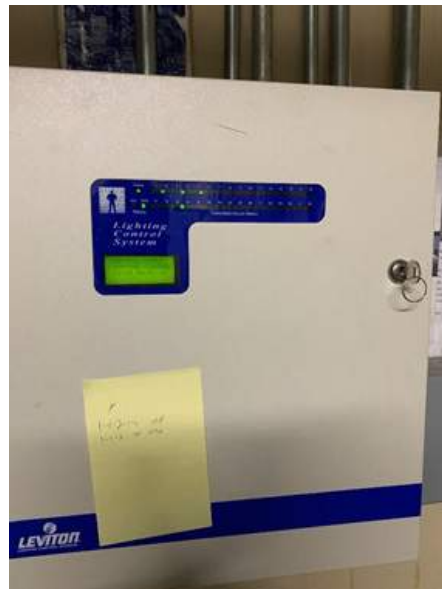
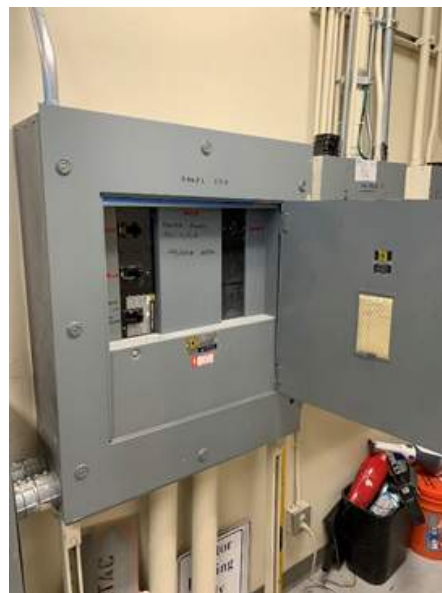
*Top: Building lighting control panel located in the first floor central electrical closet.*

*Bottom: Panel SDP, the primary building 208V distribution panelboard.*

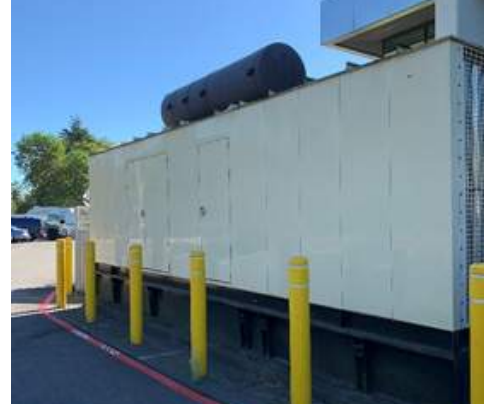
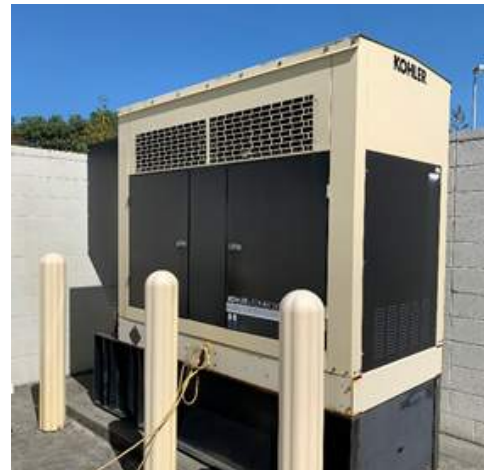
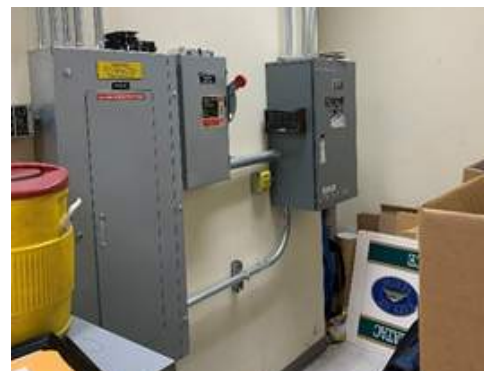
Top: The 600 kW diesel generator at the north corner of the building.

Middle: The 80 kW diesel generator at the police station sally port.

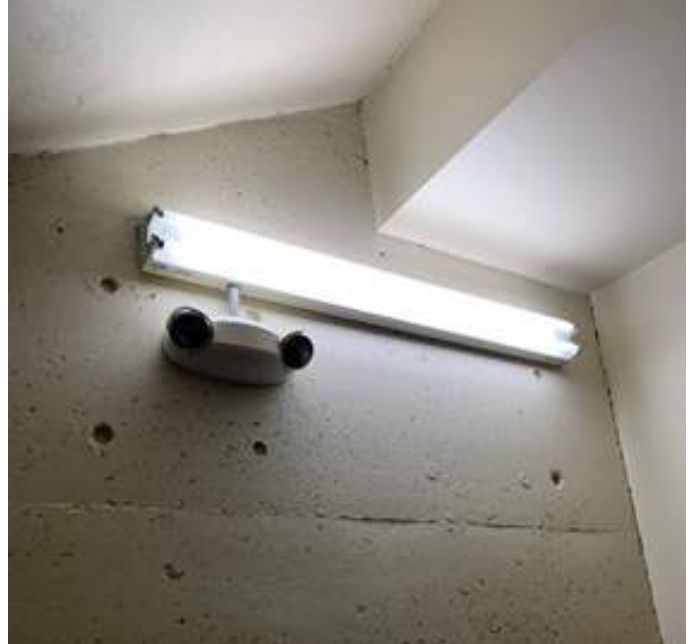
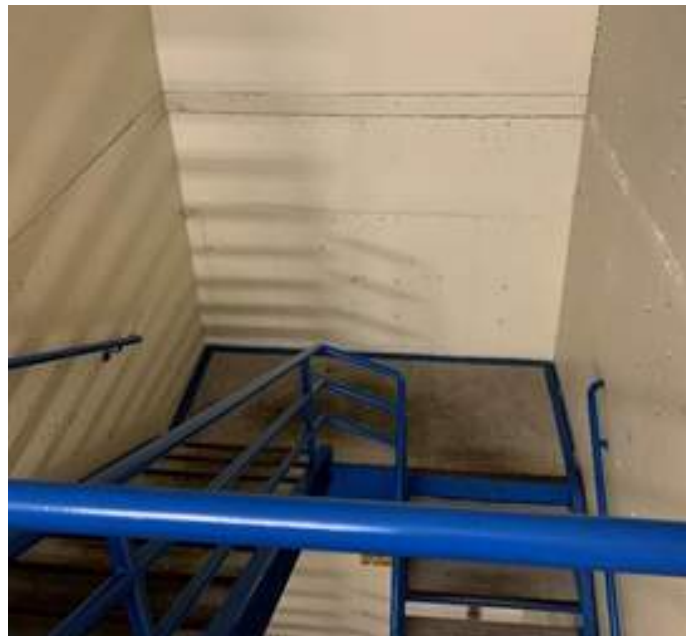
*Top: Typical lighting fixture and emergency lighting unit installed in stairwells at alternate landings*

*Middle: No lighting fixtures installed at alternating landings in stairwells. It is unlikely that code required minimum emergency egress lighting is provided.*

The "bug-eye" emergency lighting units installed in stairwells appear to be original to the building. These units utilize inefficient incandescent sources and have exceeded their expected useful life of 10 years. It is recommended to replace all emergency lighting units with new LED source units. Additionally, the emergency lighting units are only provided at alternating stair landings and it is unlikely that the code minimum of 1 footcandle average is provided along the path of egress. It is recommended that an additional emergency lighting fixture be provided at landings without one currently.

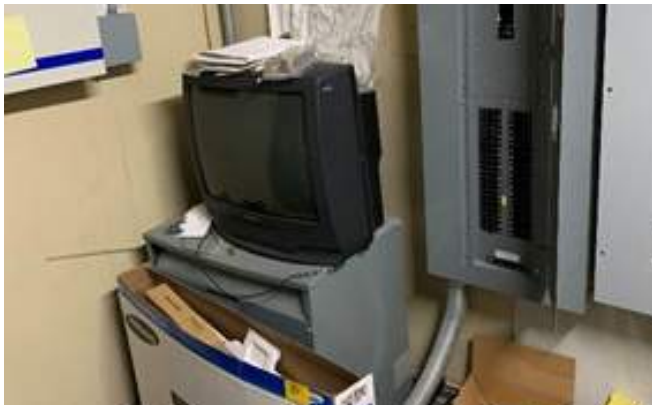
*Top: First floor central electrical closet area in front of Panels J and JA and the associated transformer is being used for storage. The NEC required working space in front of panelboards should be kept clear of foreign objects.*

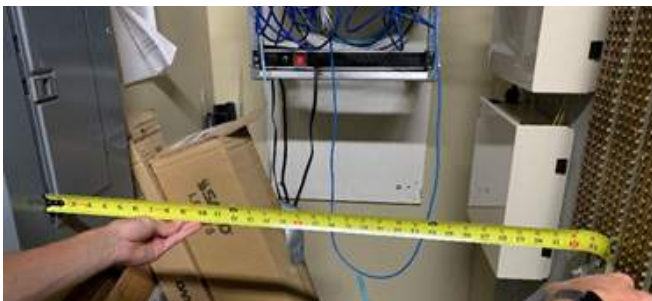
Panel QO, a 100A, 120/208V load center located in the 2nd floor central electrical closet is not provided with NEC article 110.26(A) (1) minimum clearance of 36" in front of the panel. Due to the lack of available wall space in the closet, it is likely the load center will need to be relocated somewhere outside of the closet in order to meet code clearance requirements.

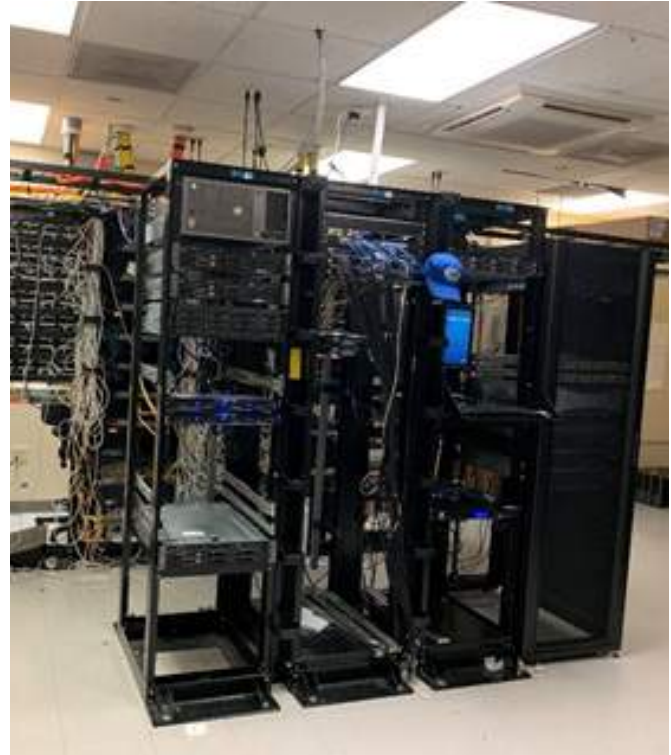
*Above: Third floor main server room and main distribution frame houses all servers and systems for the city.*

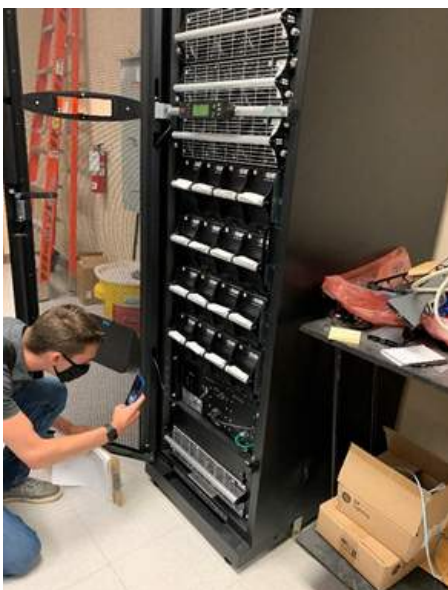
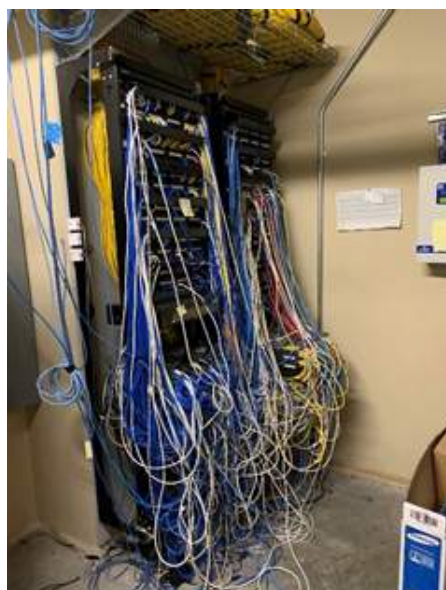
*Left: Environmentally-controlled server room UPS system. Middle: Typical IDF room - not well-organized or climate controlled. Right: Second floor north IT space.*

The stacked IDF spaces are collocated with electrical distribution and are not environmentally controlled. Recommend the three stacked space should be separated from the electrical distribution rooms and be provided with environmental controls. Additionally, the new spaces should be provided with proper cable management and grounding.

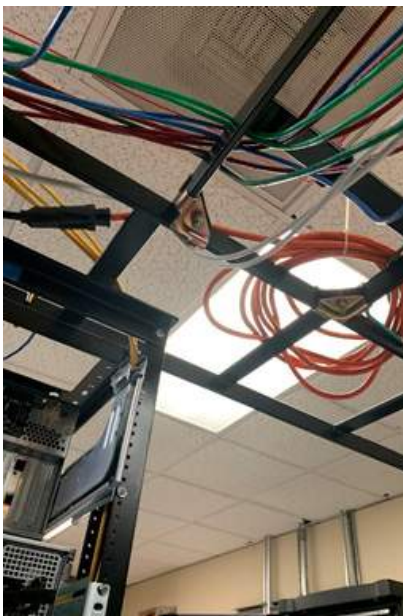
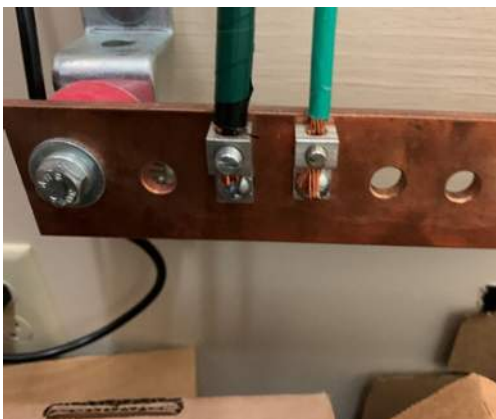
The server room Secondary Bus Bar (SBB) does exist; however, the bar is the wrong type and the wrong terminal lugs are in use. Additionally, each rack should be bonded in accordance with TIA-607-D. See the diagram on the following page.

*Top: Server room power receptacles to equipment racks. Middle: Server room rack power connected with extension cord. Above: Server room SBB is the wrong type with incorrect terminal lugs.*

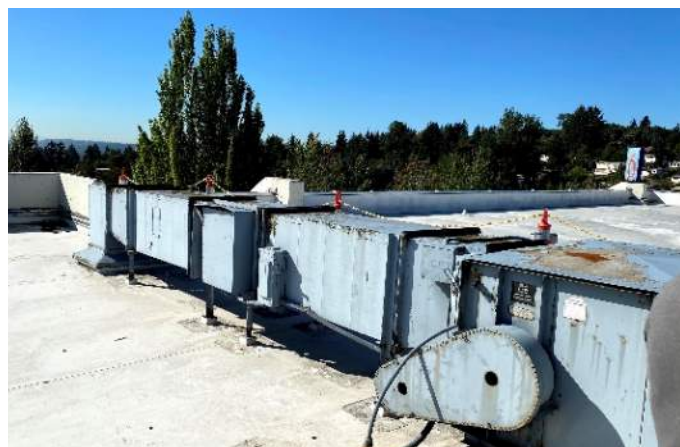
MAU-1 on the City Hall Roof

The existing MAUs and AHU have exceeded their expected service life by over 20 years. Periodic maintenance has kept this equipment functional but the equipment remains far less energy efficient and reliable than modern day air handling units. FSi recommends replacing all units with new MAUs that have electric heating coils and heat recovery.

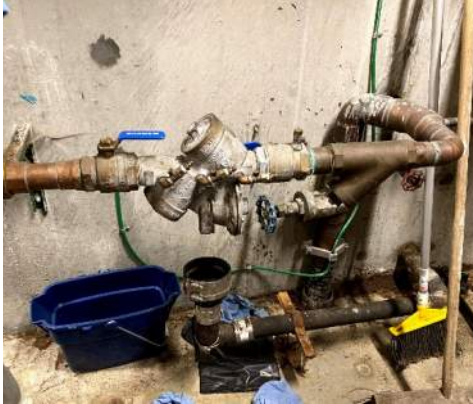
*Check Valve on Domestic Water Line*

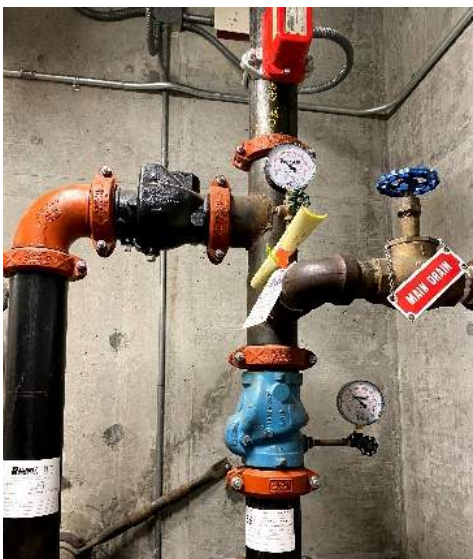
*Fire Riser Assembly*

The 4" riser is constructed of black steel piping and connected with grooved fittings and couplings. The fire protection system is regularly tested and inspected. The inspection log on the piping indicated a recent inspection in March 2020. We did not test the system, assuming it is in working condition based on the recent test. We observed minor water leakage at the base of the riser at a flanged connection. This is likely due to a worn seal between the two flanged ends. The leakage does not affect the performance of the system at this time.

NFPA 25 recommends sprinkler head replacement after 50 years with regular testing intervals of 10 years. This FIM concurs with NFPAs recommendation to increase the lifespan of the fire protection system.

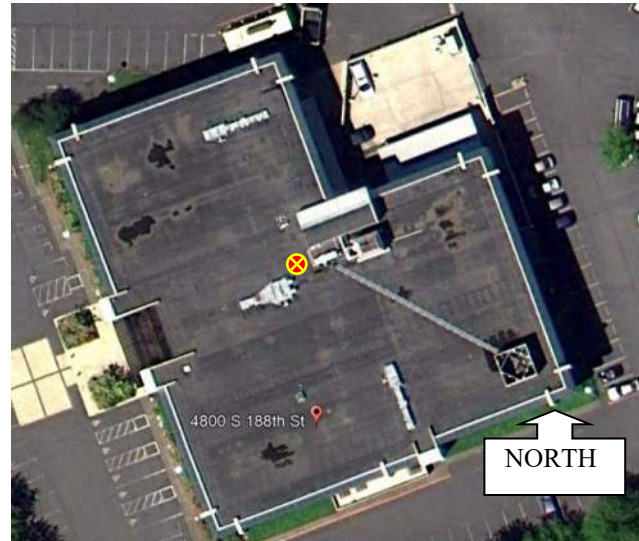
Figure 1 – Historical aerial image of roof from 6/2010 showing apparent BUR or EPDM assembly. Approximate location of core cut performed is denoted with

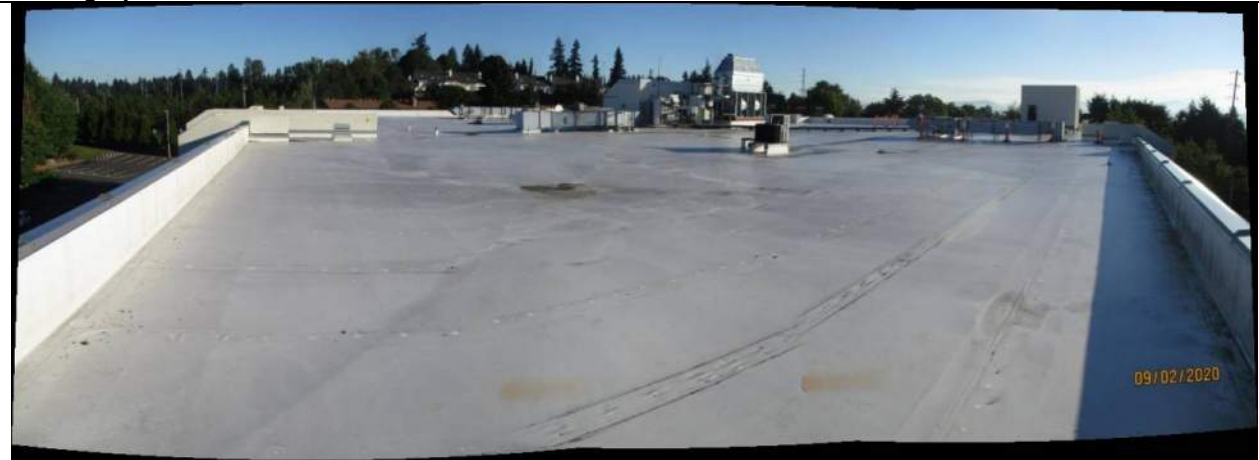
Photograph 1: Panoramic overview of the main roof as seen from the southwest corner.

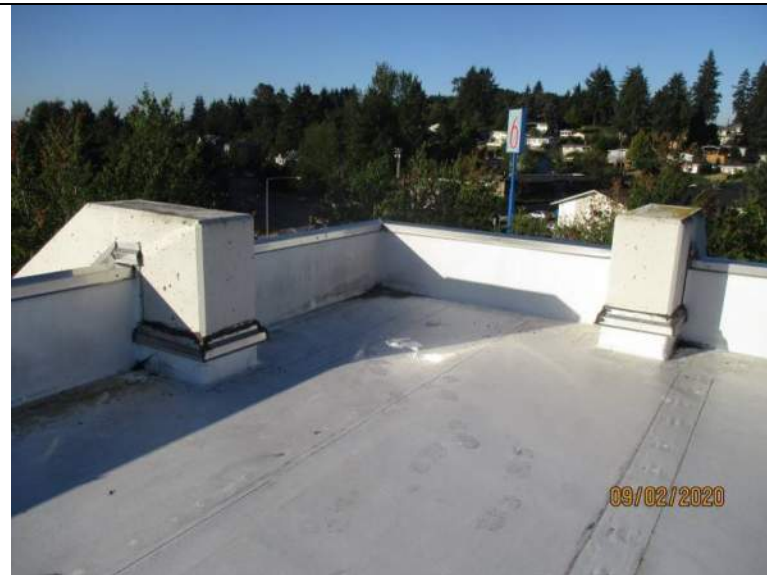
Photograph 2: Southwest corner of main roof depicting cast-in-place fin walls bisecting the parapet.

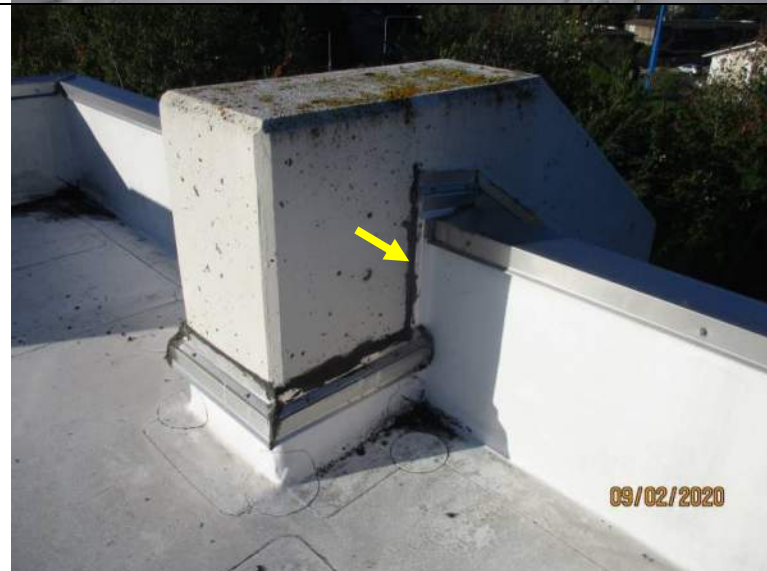
The counterflashing installation is excluded where the termination bar turns vertical at the leading edges of the wall flashing membrane at the transitions from parapet to cast-in place wall. The exposed termination bar and coping-to-wall junctions appeared to be susceptible to water intrusion. There are no transition "saddle" flashings where the parapet meets a cast-in-place wall. Instead, the wall flashing membrane and coping metal are simply tabbed up behind the counterflashing metal.

Photograph 3: Closer view of previous photograph showing two-piece metal counterflashing overlapping wall flashing membrane and coping metal tab. Note exposed vertical termination bar (arrow) with topical sealant that requires routine monitoring and maintenance.

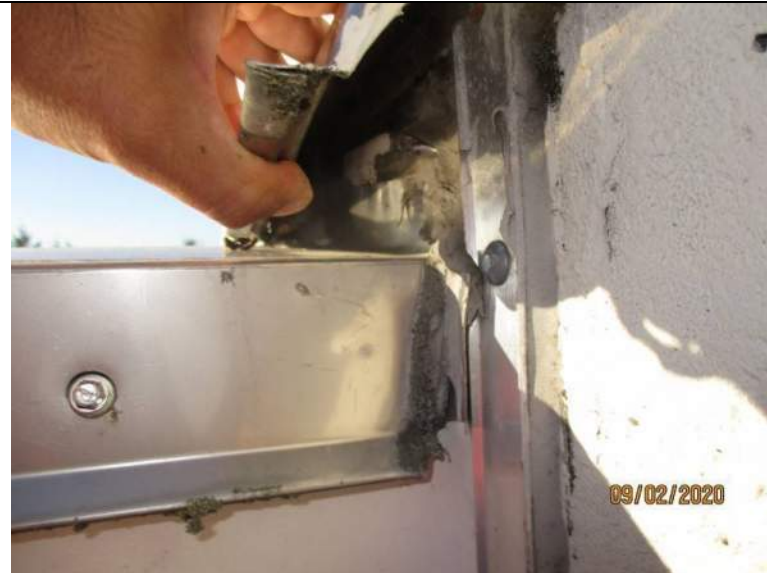
Photograph 4: View of tabbed up coping metal and single-ply membrane where the top of the parapet meets a cast-in-place fin wall.

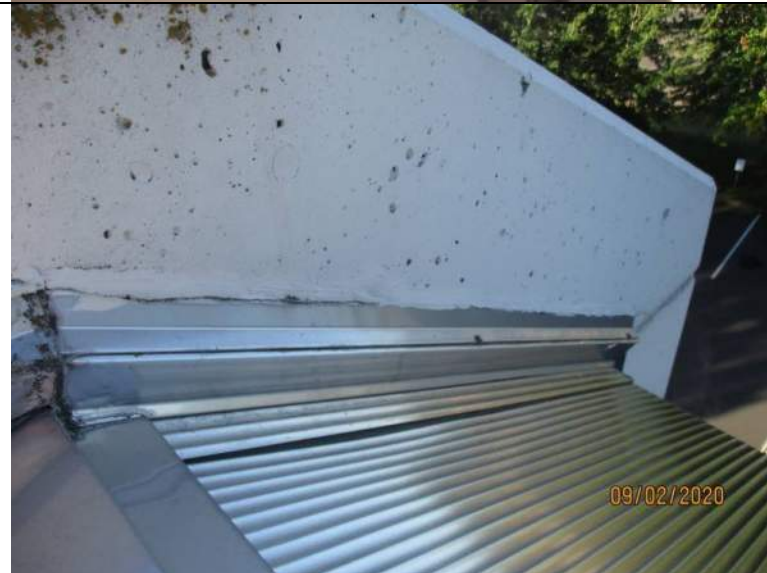
Photograph 5: Typical two-piece counterflashing assembly that overlaps an L-metal transition flashing where the perimeter metal panel roof interfaces the cast-in-place walls.

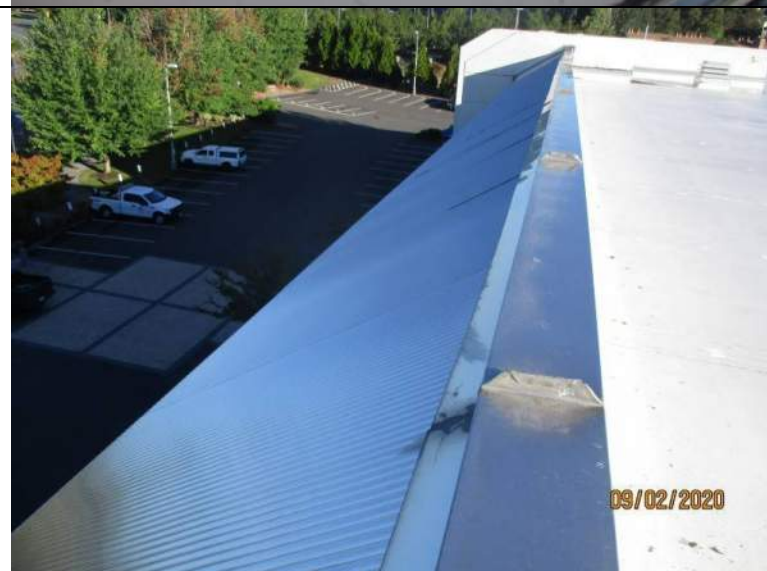
Photograph 9: Overview of perimeter metal panel roof, showing roof-to-wall flashing/cleat and standing seam coping.

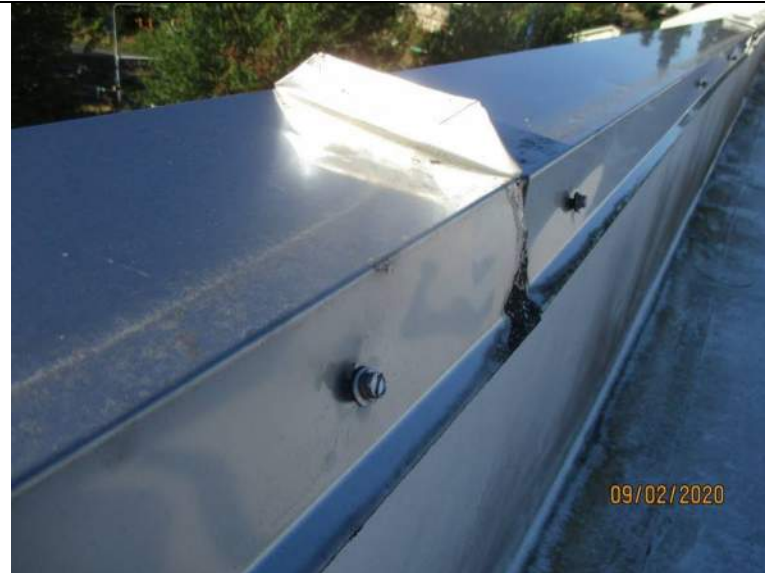
Photograph 10: Close up of parapet coping, showing underdriven screw fasteners along the inside return.

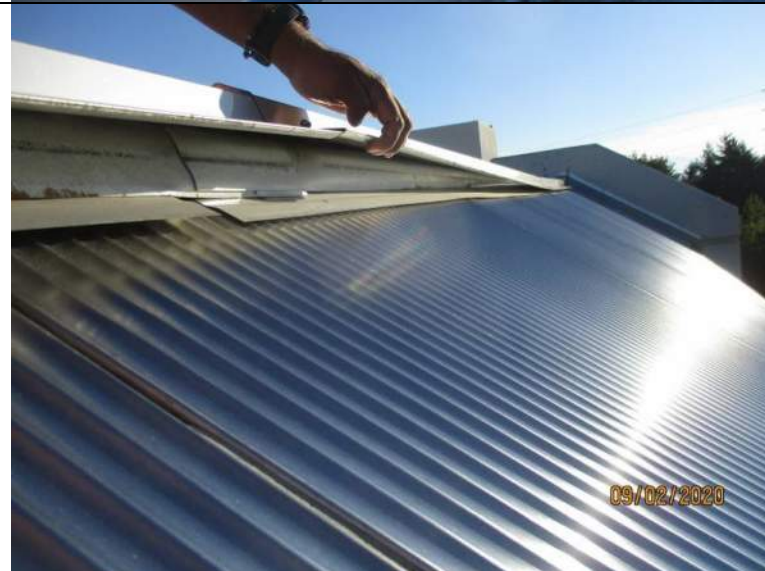
Photograph 11: Exterior view of coping metal not engaged into the roof-to-wall flashing/cleat and at risk of blow-off.

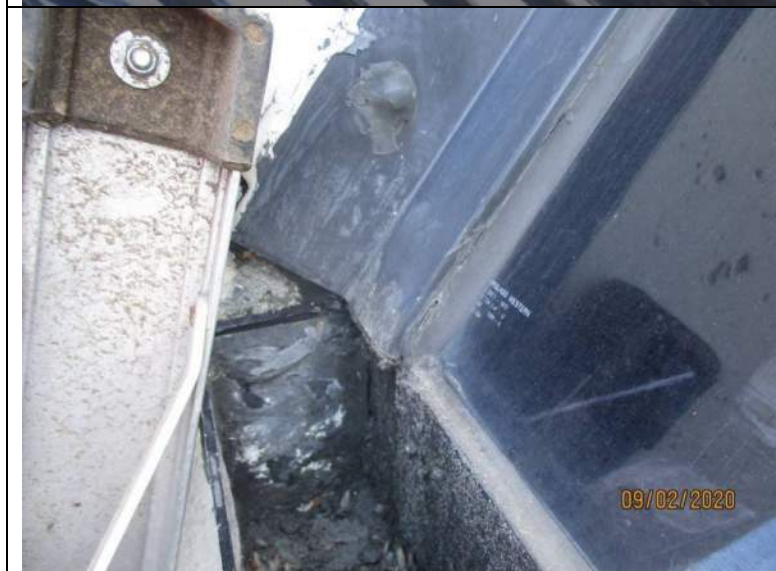
Photograph 15: Downslope edge of lobby skylight showing rake-to-eave transition. Note presence of a built-in sheet metal gutter.

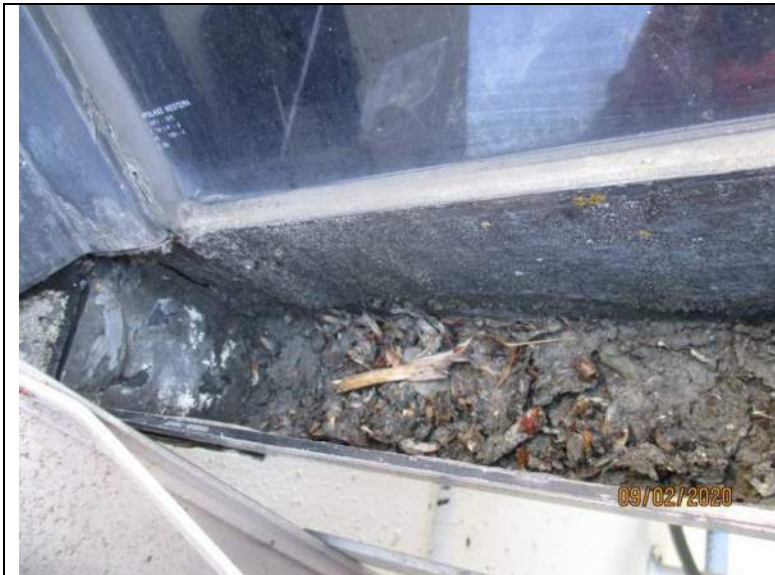
Photograph 16: Debris in built-in gutter.

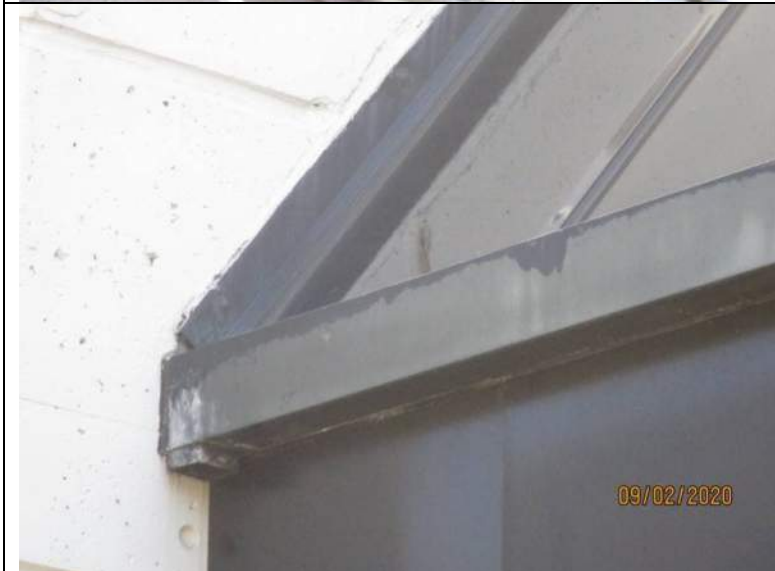
Photograph 17: Context view of previous photos. Note lack of downspout to help control drainage.

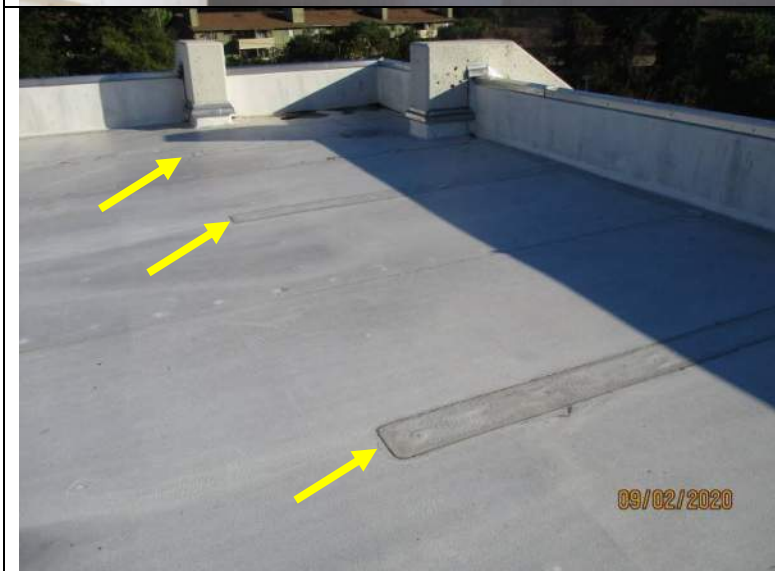
Photograph 18: Stripped in rows of membrane fasteners at corner of main roof for added wind uplift resistance.

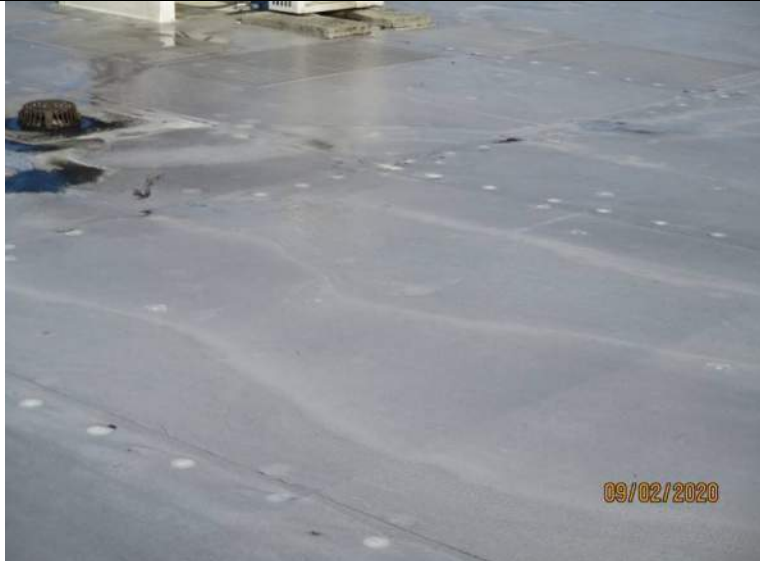
<p>Photograph 19: In-seam membrane fasteners spaced at approximately 12-inches on center telegraphing through membrane due to thermal birding.</p>

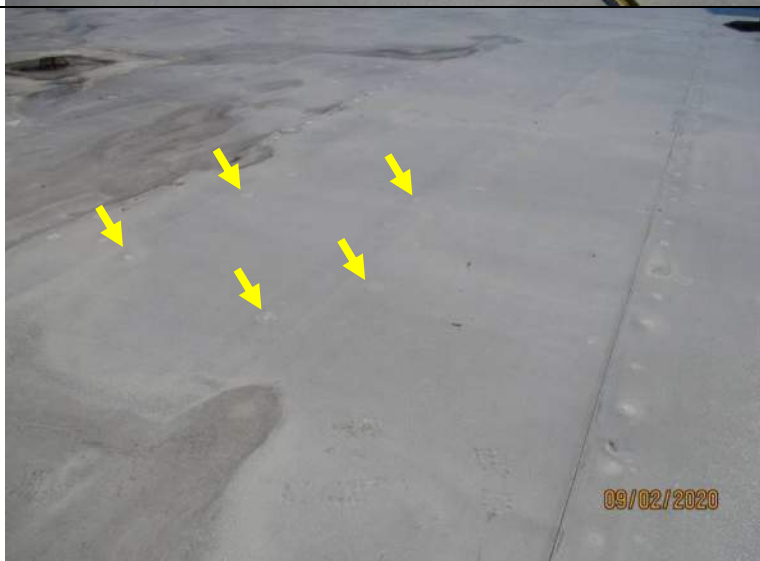
<p>Photograph 21: Telegraphing of insulation board fastener plates under field of membrane. Estimated about 6 to 8 fasteners used per 4-foot by 8-foot board.</p>

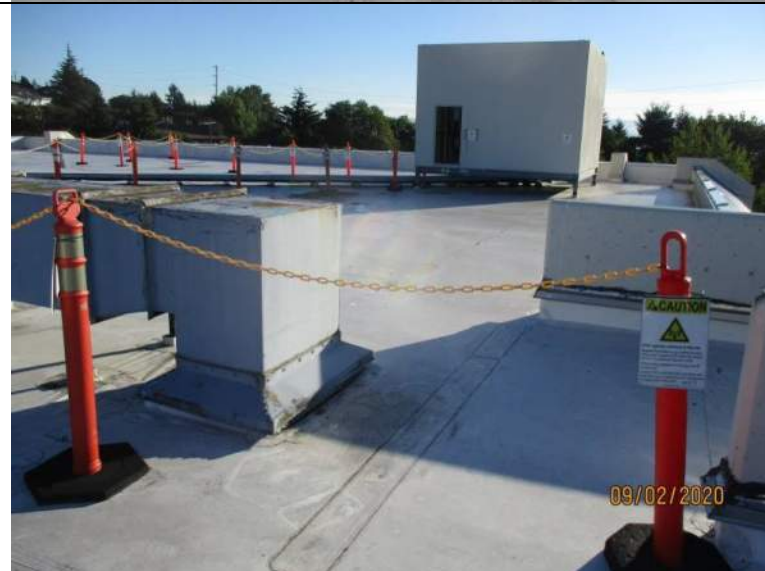
Photograph 23: Context view of shrouded cell site antenna equipment at southeast corner of main roof.

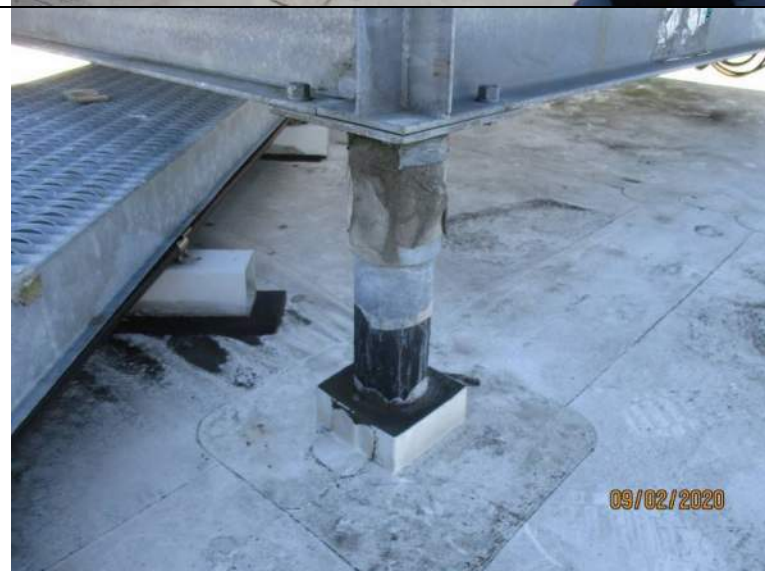
Photograph 24: View of cell site antenna platform post with clad-metal pocket, filled with pourable sealer, to flash roof penetration and fabric faced butyl tape, similar to Eternabond WebSeal, used to cover the bolt connection points from post to sleeve under the steel I-beams.

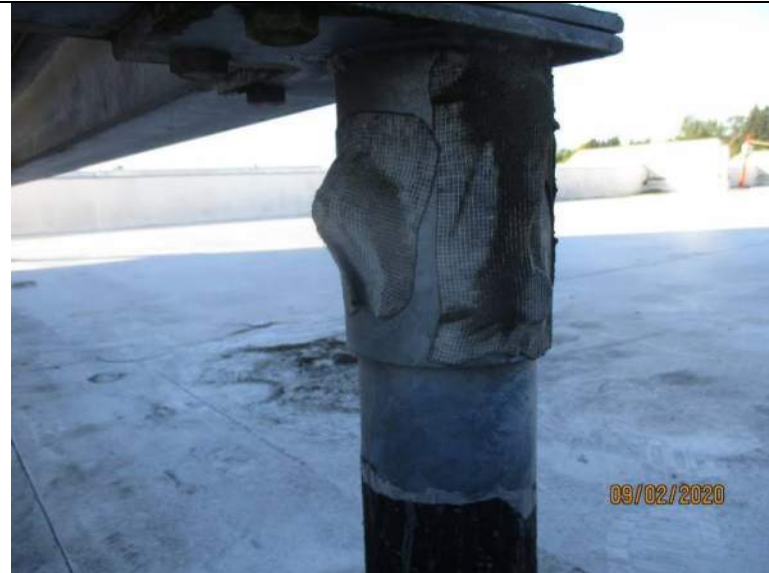
Photograph 25: Closer view of previous showing roof tape.

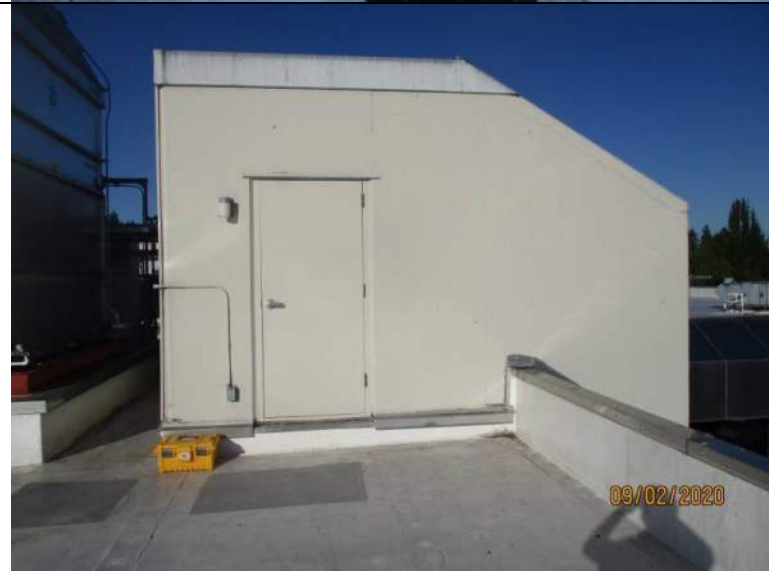
Photograph 26: Context view of east staircase penthouse, east elevation. Note roof transition from low to steep slope.

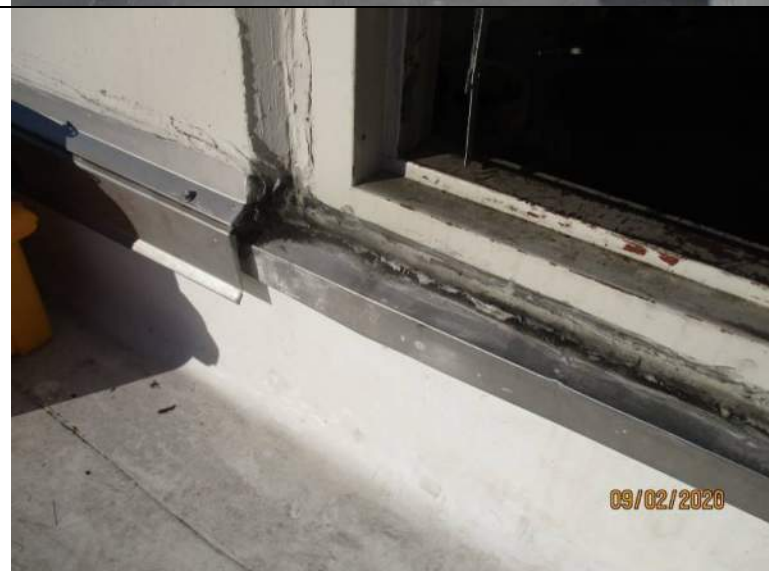
Photograph 27: Sealant dependent flashing termination under door frame at sill, and at transition to roof counterflashing metal.

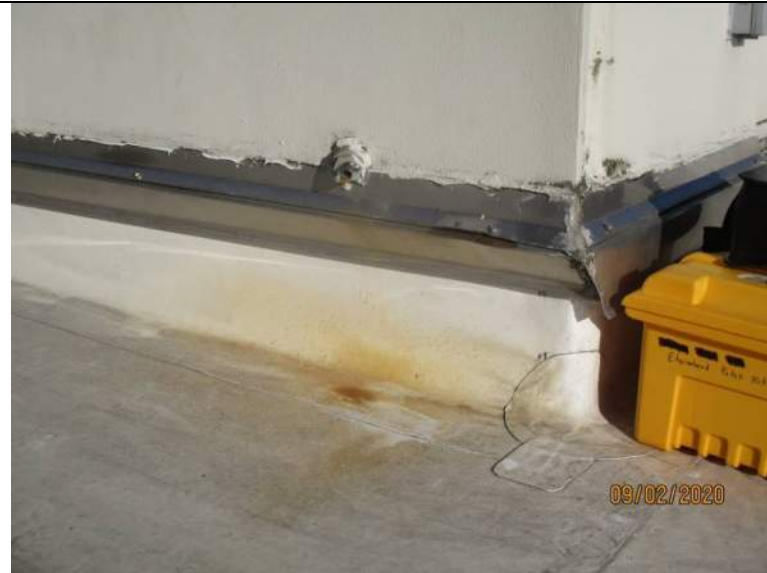
Photograph 28: Two-piece metal counterflashing at base of penthouse. Note continued reliance of sealant due to having exposed concrete walls above.

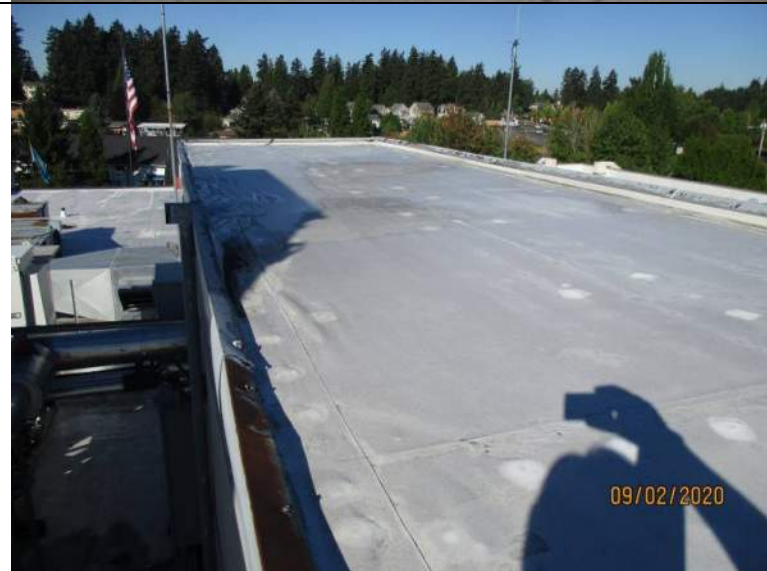
Photograph 29: Penthouse roof looking west.

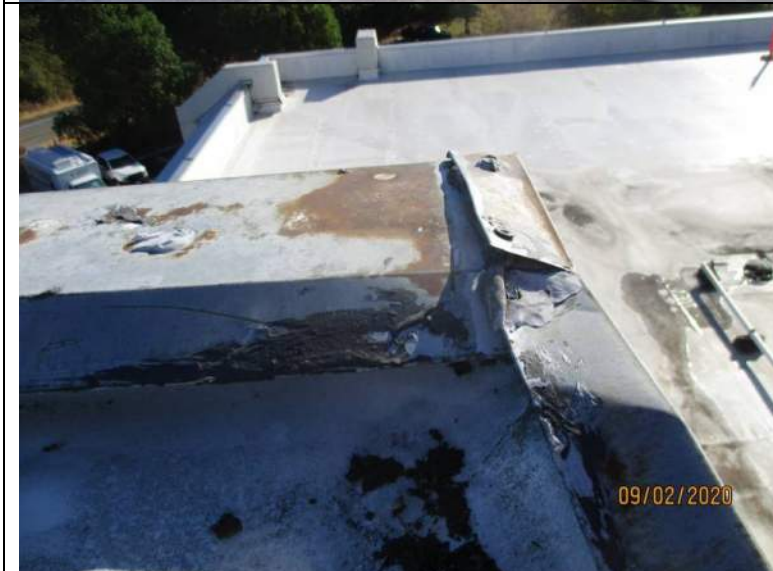
Photograph 32: Poor coping metal transition to peak edge metal.

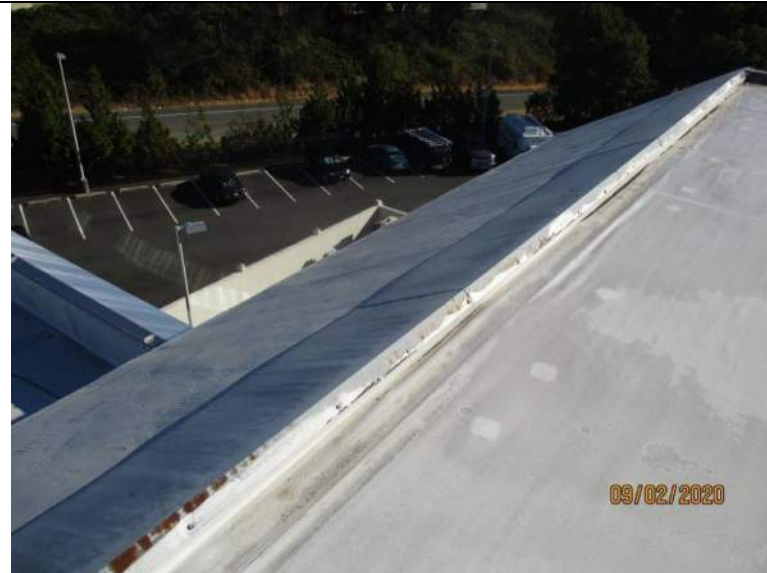
Photograph 34: Peak edge metal flashing at north perimeter of penthouse roof, transition to steep slope.

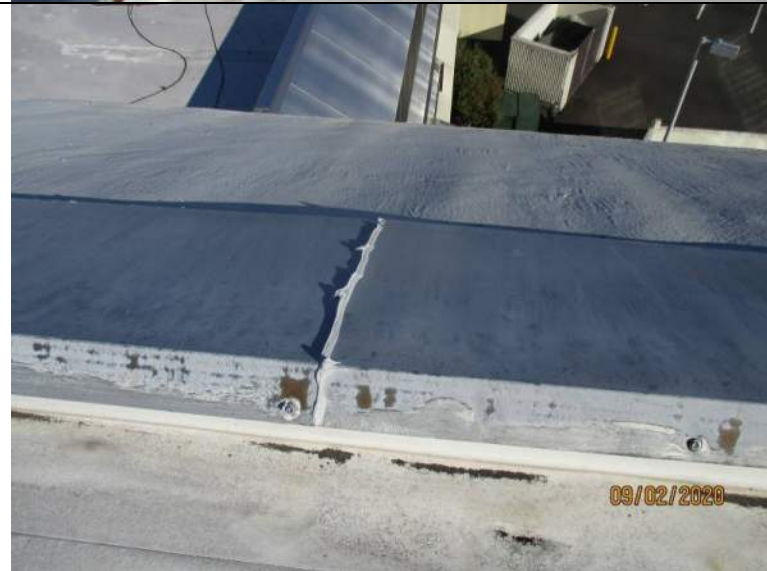
Photograph 35: Topically applied sealant over joint in peak edge metal flashing.

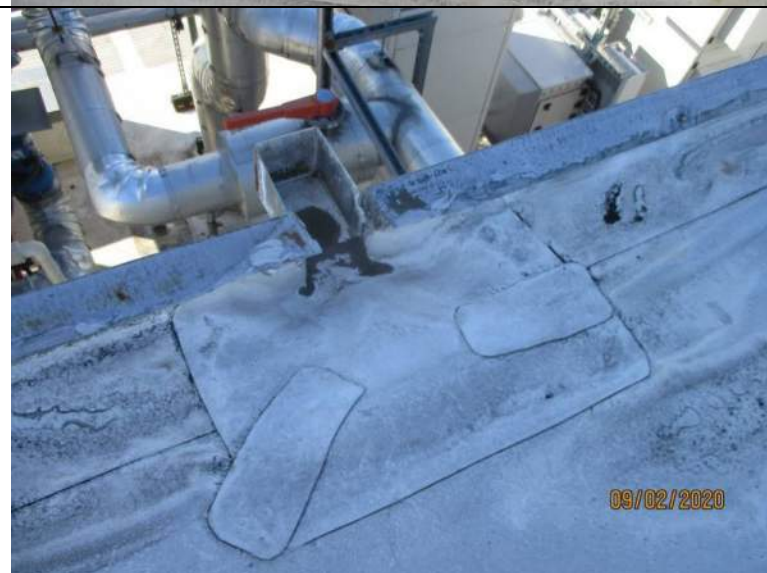
Photograph 36: Scupper box at south edge of penthouse roof.
