# CITY OF SEATAC CITY HALL

## ASSESSMENT & ANALYSIS FOR THE REDEVELOPMENT OF SEATAC CITY HALL

Prepared in accordance with the  
Agreement for Professional Services between  
City of SeaTac, WA and ARC Architects

March 2021

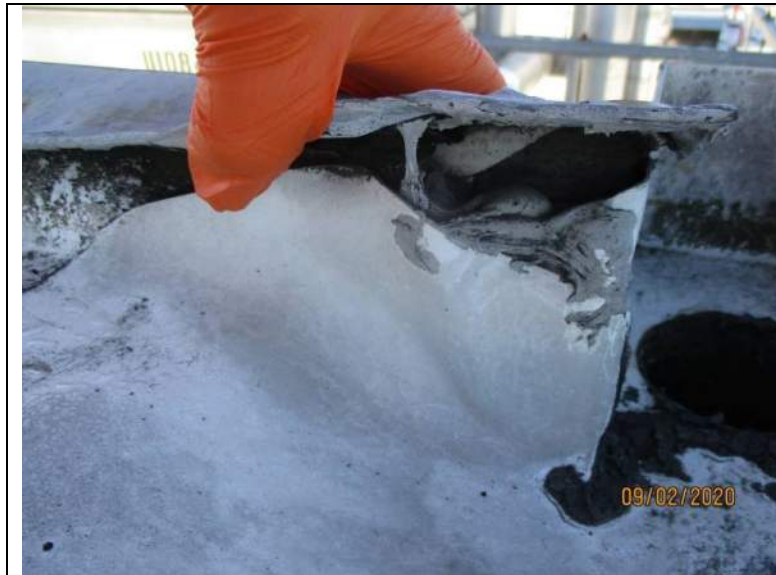
Photograph 37: Poor detailing at side of scupper box showing lack of proper integration and flashing.

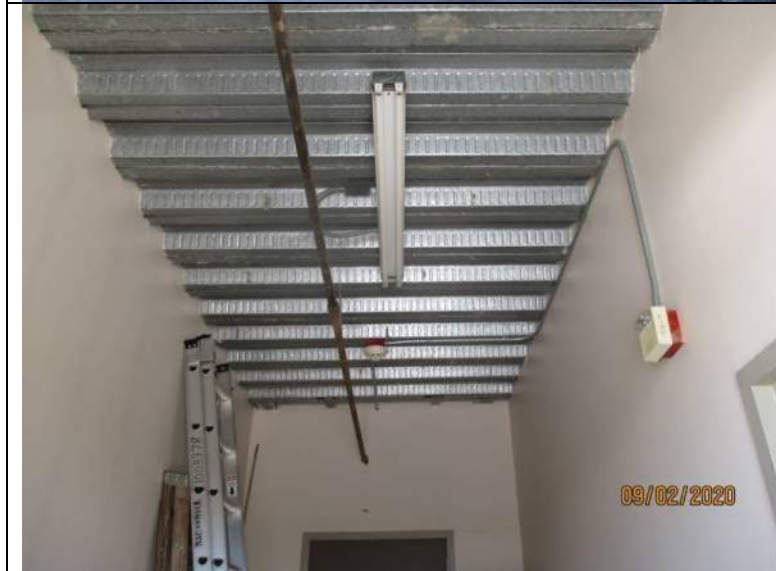
Photograph 38: Underside of low slope penthouse roof showing pan decking under concrete.

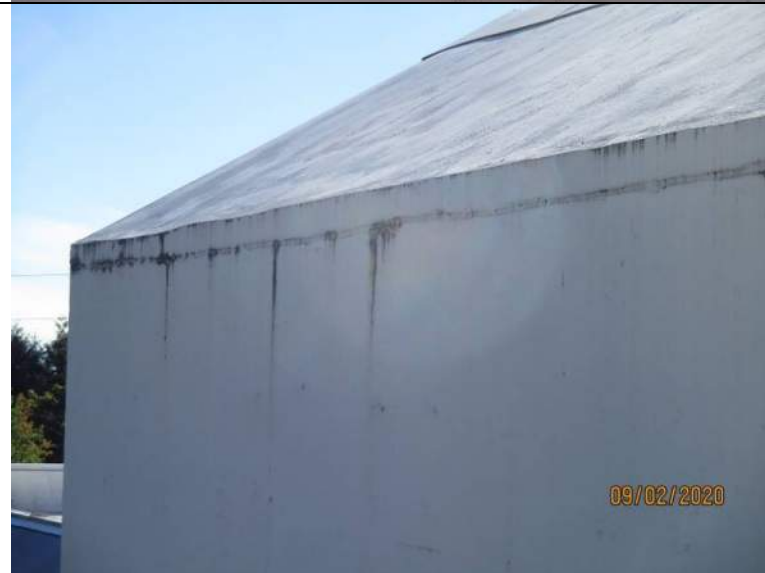
Photograph 41: Same location as previous photograph as seen from the exterior, north elevation of penthouse.

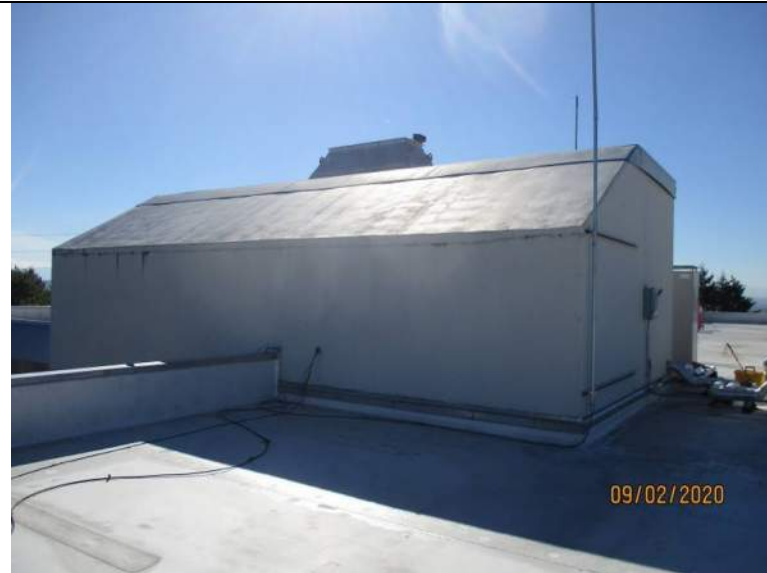
Photograph 43: Context view of east staircase penthouse, north and west elevations.

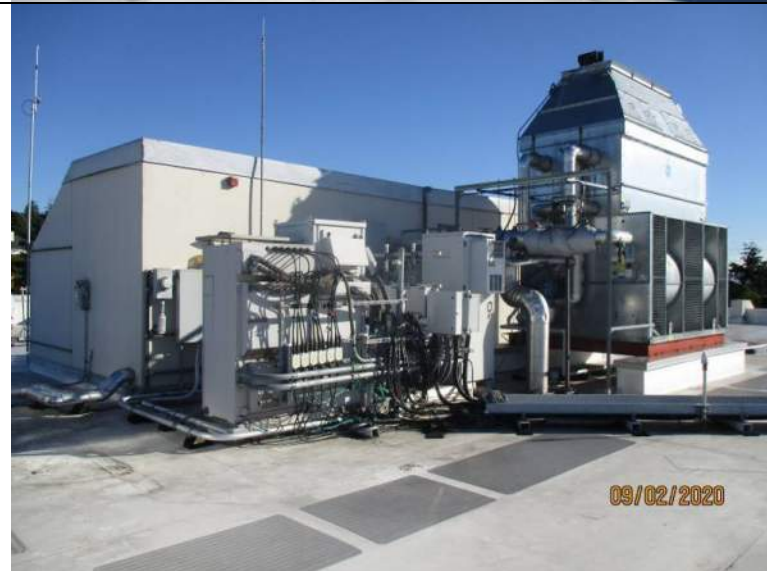
Photograph 44: Cell site equipment and chiller next to south elevation of east staircase penthouse.

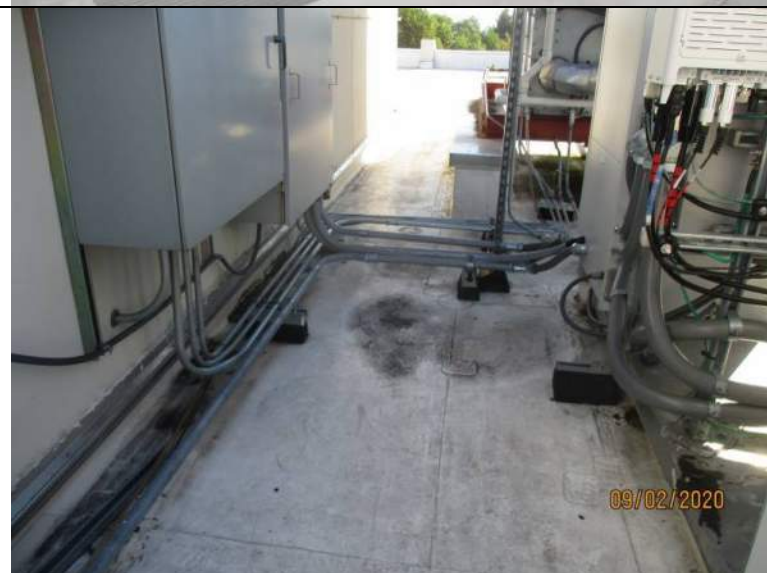
Photograph 45: Roof area between cell site equipment and penthouse that felt soft when walked on.

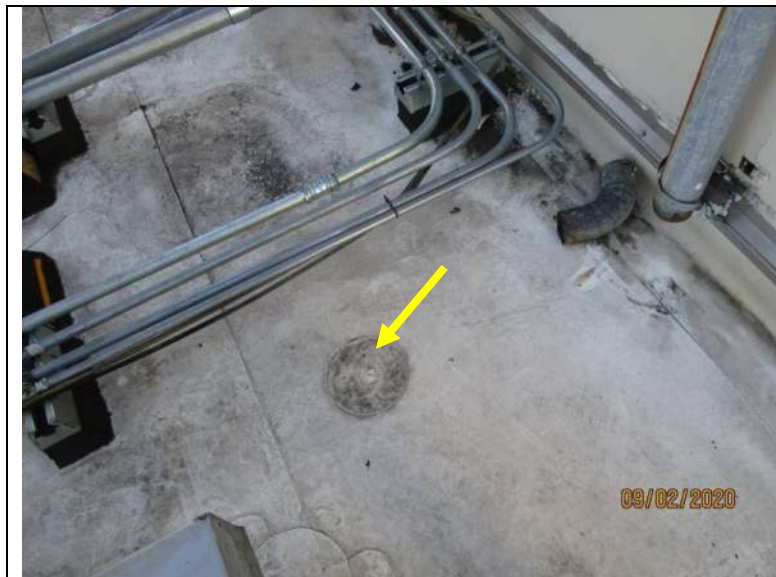
Photograph 46: Same area as referenced in previous photograph showing round membrane patch over fastener that is tenting the membrane.

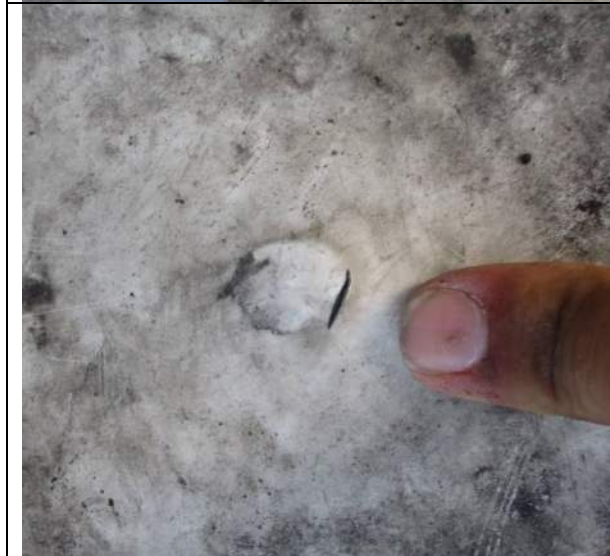
Photograph 47: Close up of previous photograph showing membrane starting to split from fastener that is protruding over compressed/soft underlying insulation materials.

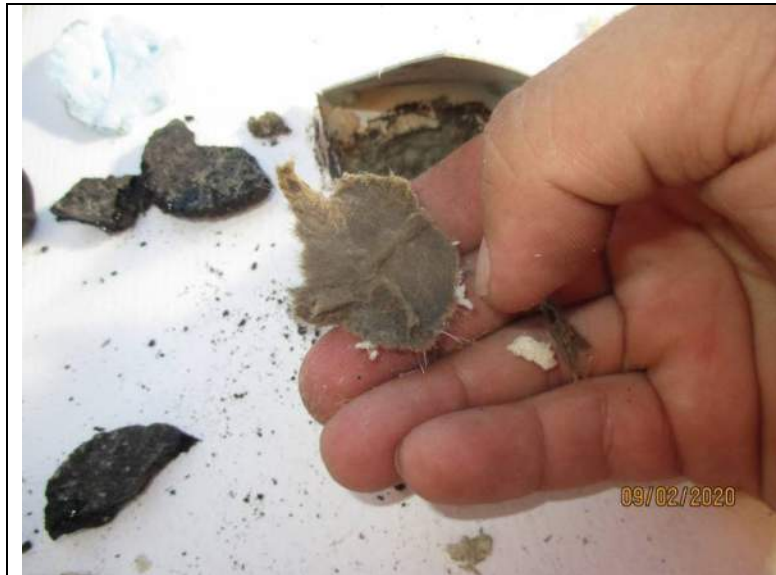
Photograph 53: Close up of polyiso insulation facer removed from core exhibiting some dampness.

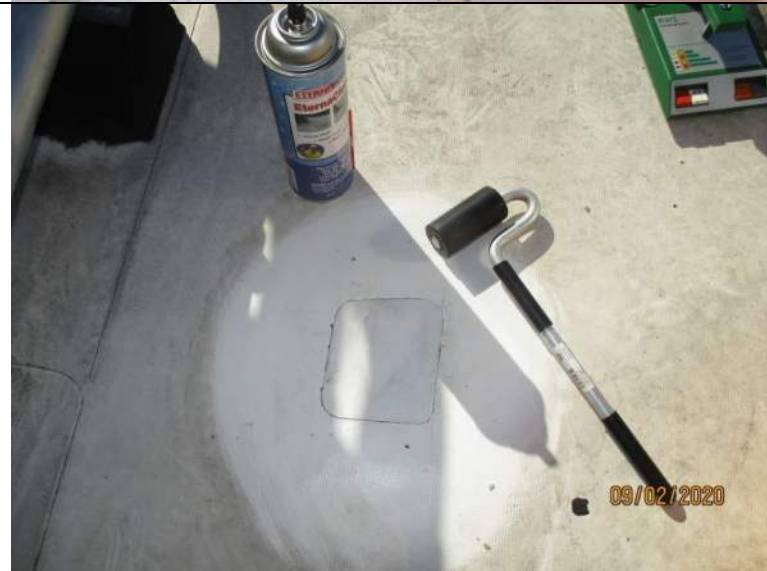
Photograph 54: Core cut patches with an under-over butyl roof tape patch over a cleaned membrane surface. Core cut location should be permanently patched with hot-air welded membrane.

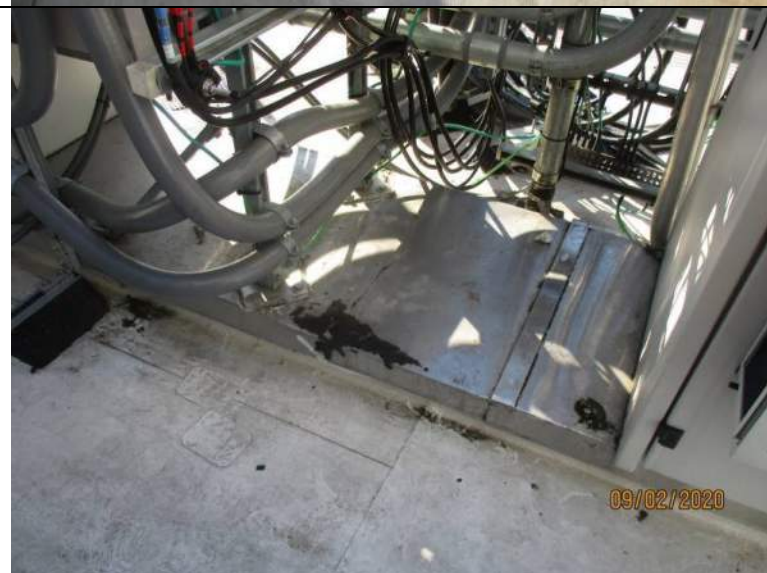
Photograph 55: Pan flashing over curb where cell site equipment is located.

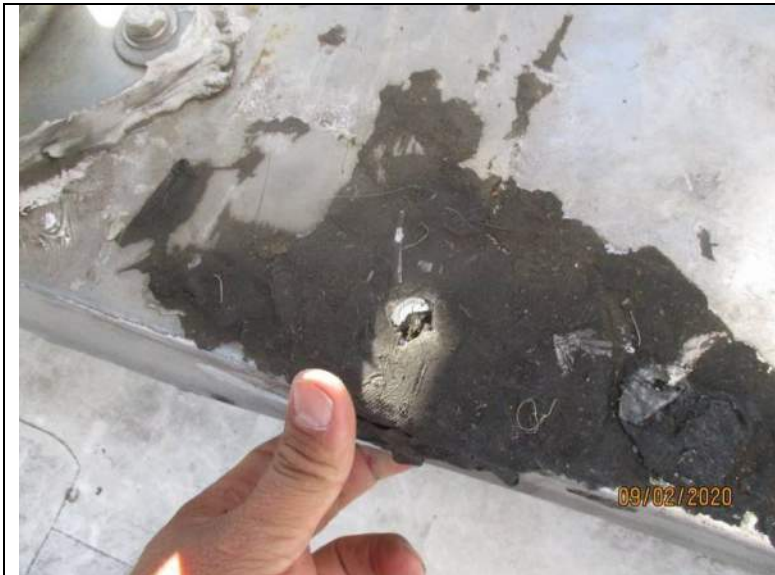
Photograph 56: Close up of previous photograph showing hole in pan flashing from removed/relocated fastener.

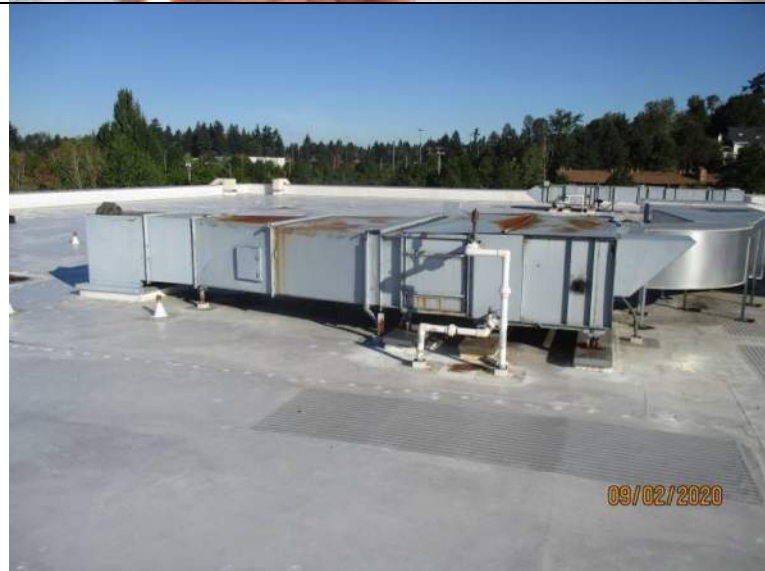
Photograph 57: Context view of duct work near middle of main roof.

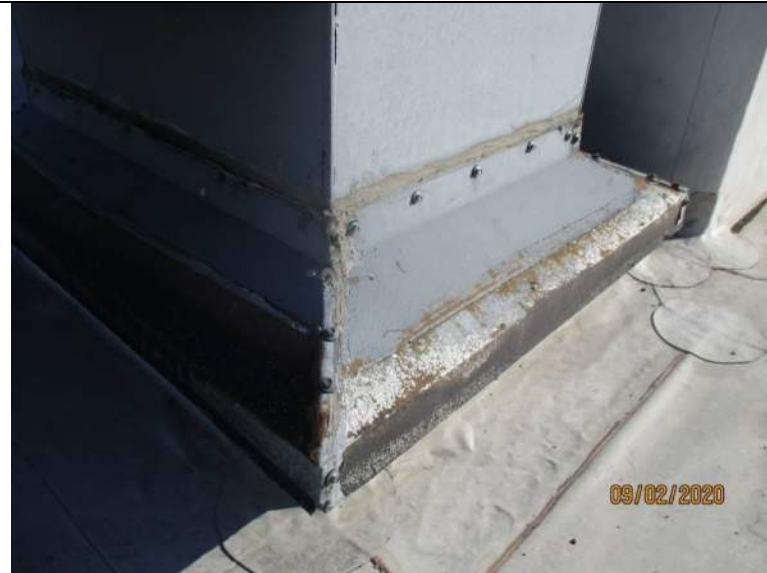
Photograph 62: Sealant dependent joints in sheet metal flashing around duct penetration and at miter.

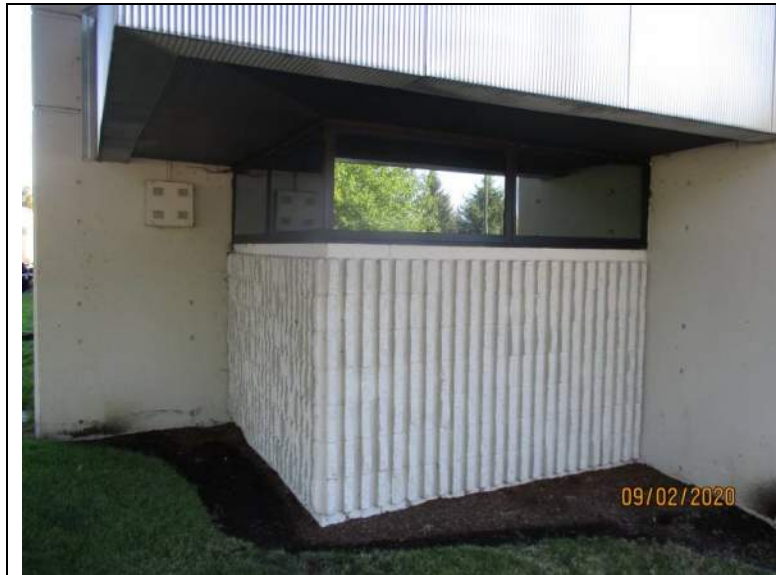
Photograph 67: Fluted CMU base at building corner between cast-in-place walls. Aluminum framed strip windows and metal panel structure above.

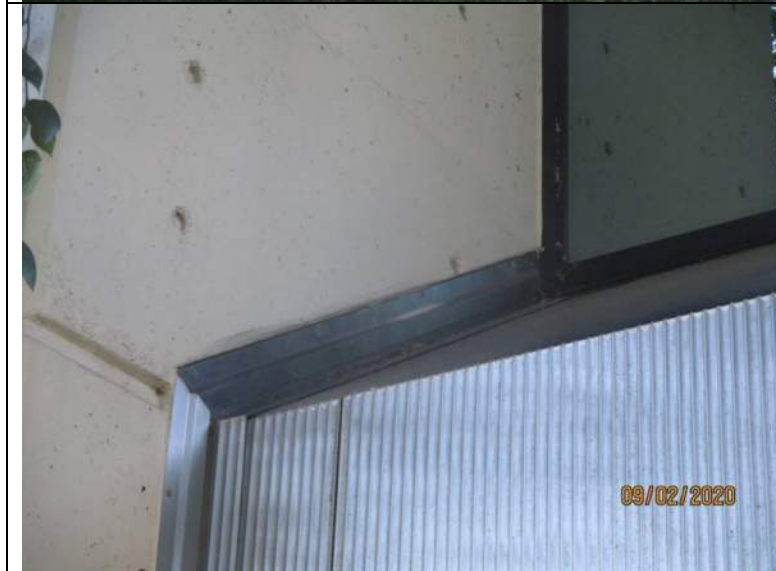
Photograph 68: Surface mounted counterflashing where metal structure meets cast-in place wall.

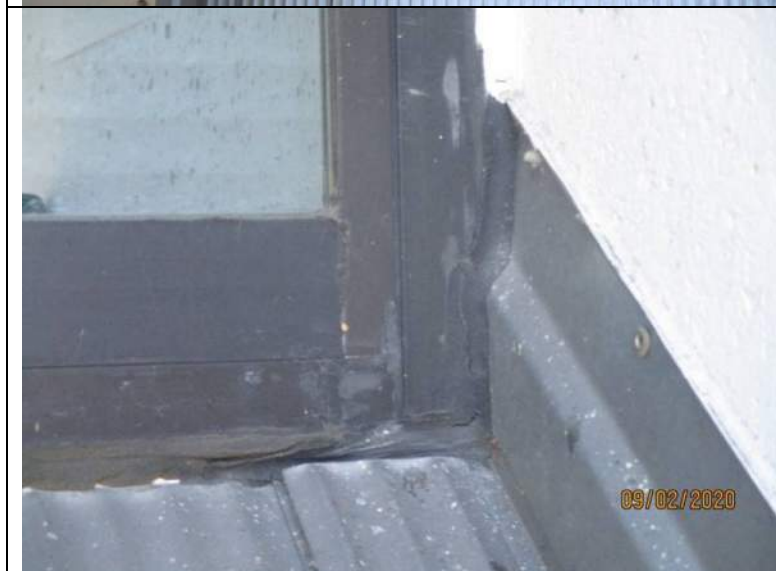
Photograph 69: Sealant dependent junction where surface mounted counterflashing interfaces with window frame and along bottom of window.

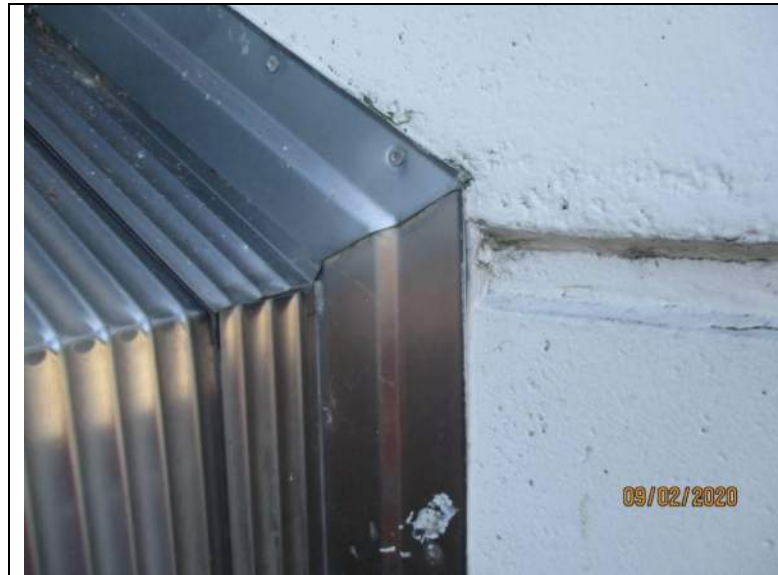
Photograph 73: Surface mounted counterflashing transition down front face of metal panel structure.

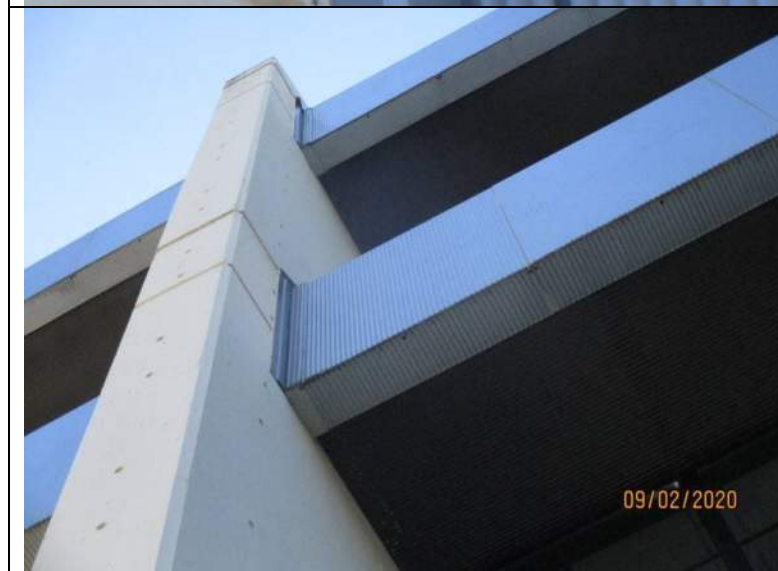
Photograph 75: Looking up at metal structures interfacing with the cast-in-place concrete walls. Note weep holes along bottom edge.

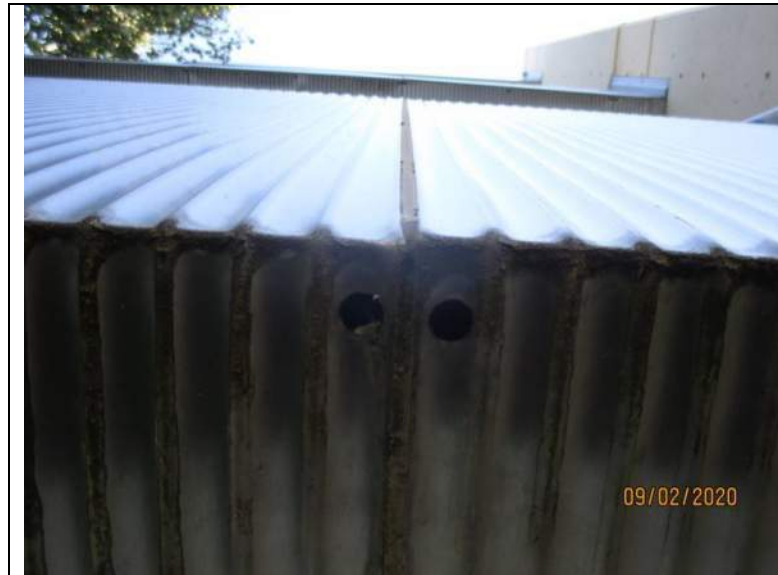
Photograph 76: Close up view of weep holes in bottom edge of metal soffits.

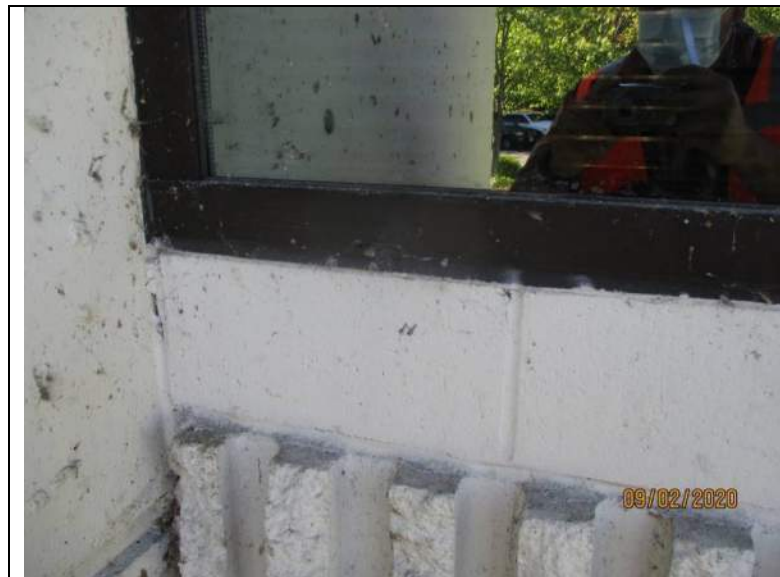
Photograph 79: Window sill condition above fluted CMU elevation.

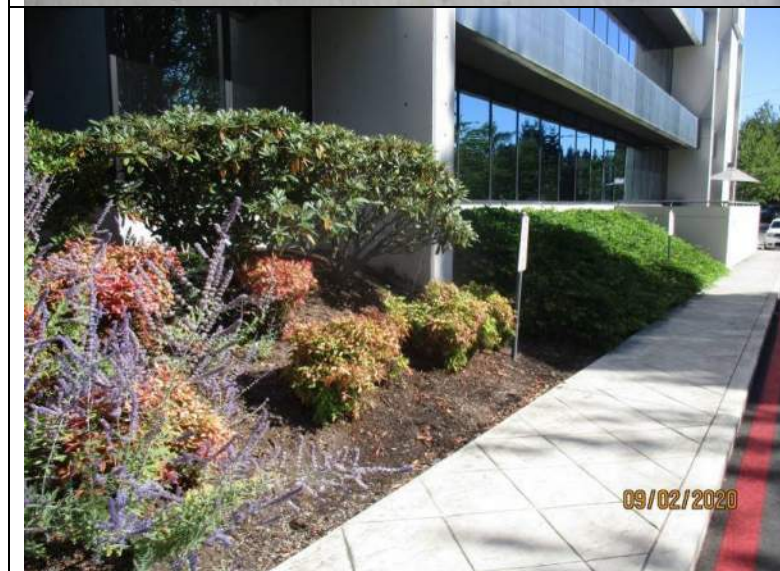
Photograph 81: Landscaping mounded above the interior floor line around most of the building perimeter. Review of any waterproofing components on the wall behind the landscaping could not be visually confirmed without excavation.

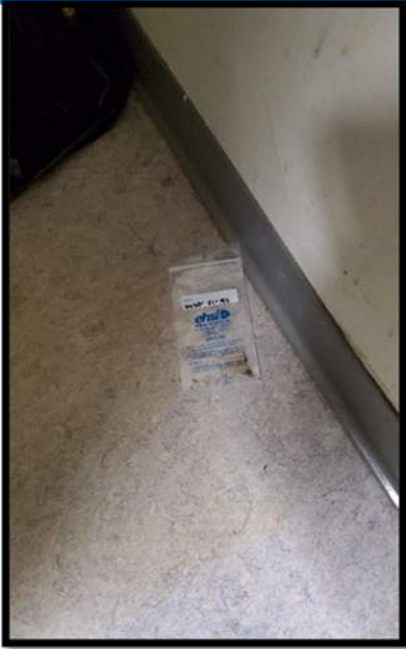
**Photo 1—Sample 11420-F1-92:**  
Non-ACM 1'x1' Vinyl Tile over **brown fibrous material** on concrete **3% Chrysotile**

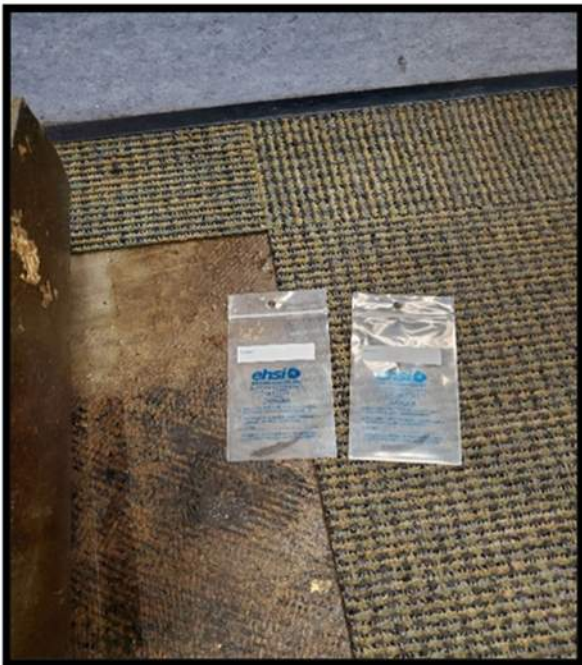
**Photo 3—Sample 11420-F1-124:**  
Non-ACM carpet over **black/yellow mastic** **6% Chrysotile**

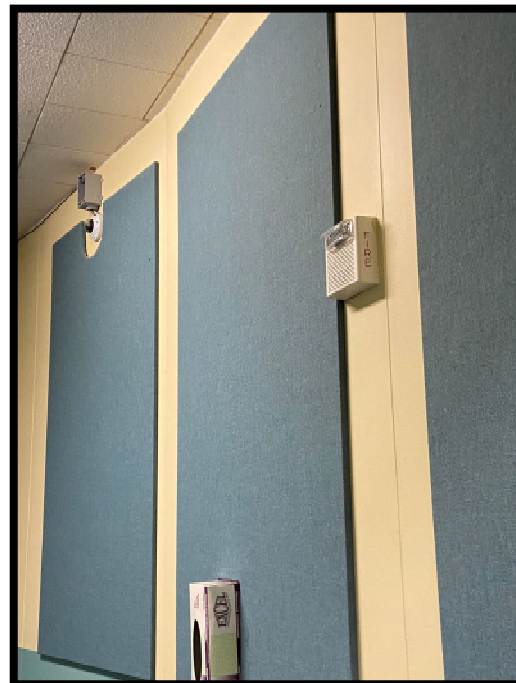
**Photo 4—Sample 1142-F1-129:**  
Non-ACM blue fibrous cover over **yellow mastic** on wall (for blue fibrous panels)

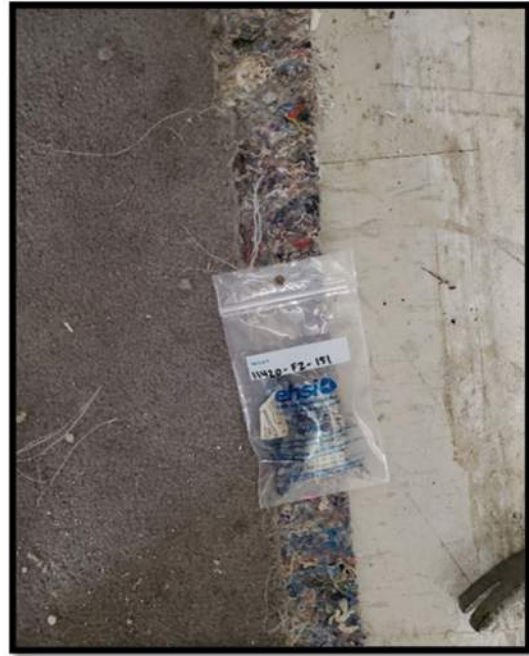
**Photo 6—Sample 11420-F2-151:** Non-ACM multi-colored carpet and leveling compound over **white VAT** **7% Chrysotile** and **black mastic 10% Chrysotile**

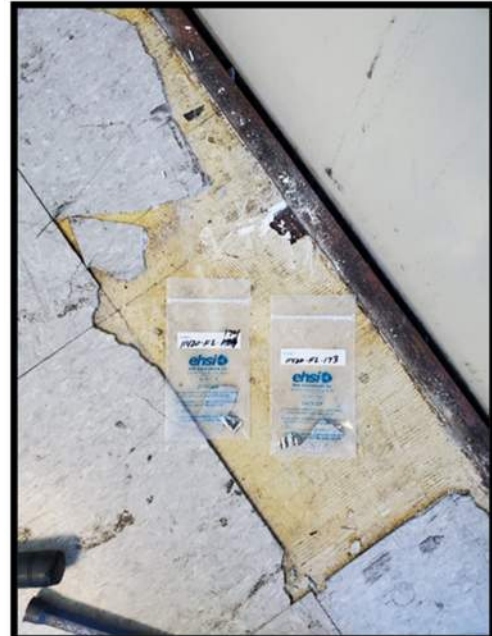
**Photo 8—Sample 11420-F2-173:** Non-ACM **Gray vinyl tile**, **yellow mastic**, over **white vinyl tile** and **black mastic 3-4% Chrysotile**

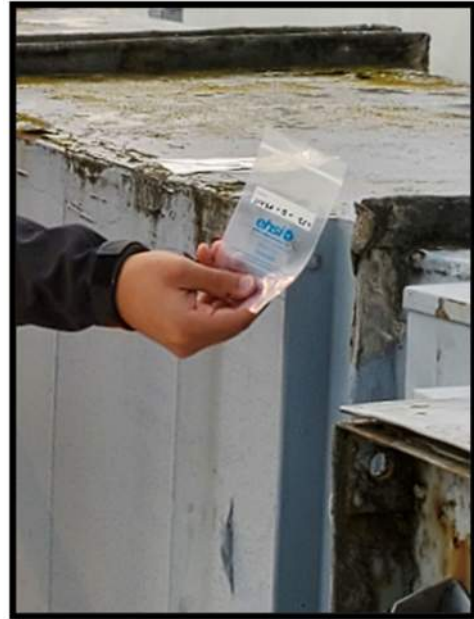
**Photo 10—Sample 11420-R-254:**  
White flex paper (on AHU top side &  
corners) 2% Chrysotile

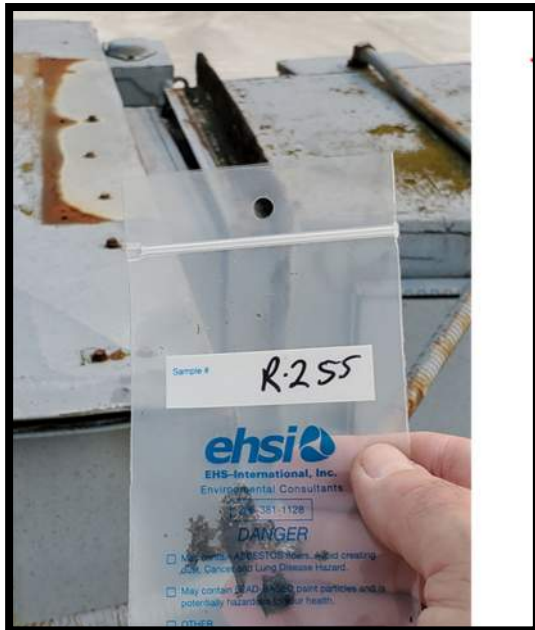
**Photo 11—Sample 11420-R-255:**  
Black flex duct (on AHU unit) 8% Chrys-  
otile

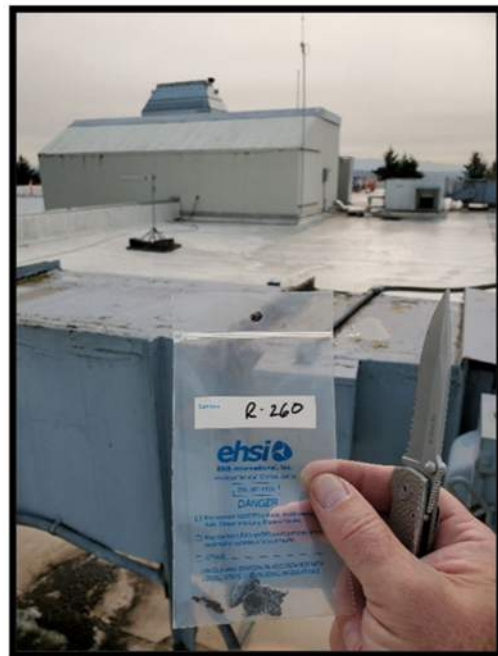
**Photo 12—Sample 11420-R-260:**  
Non-ACM white flex paper on over red  
mastic (on AHU top side & corner) 6%  
Chrysotile

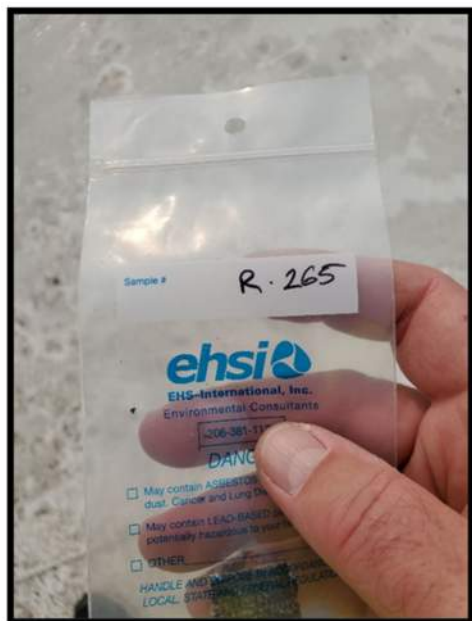
**Photo 13—Sample 11420-R-265:**  
Non-ACM white flex paper over red mas-  
tic 6% Chrysotile
